Bayshore Boulevard Hazardous Tree Survey

The Baylands Development Inc.

Baylands South Subdivision

January 13, 2022

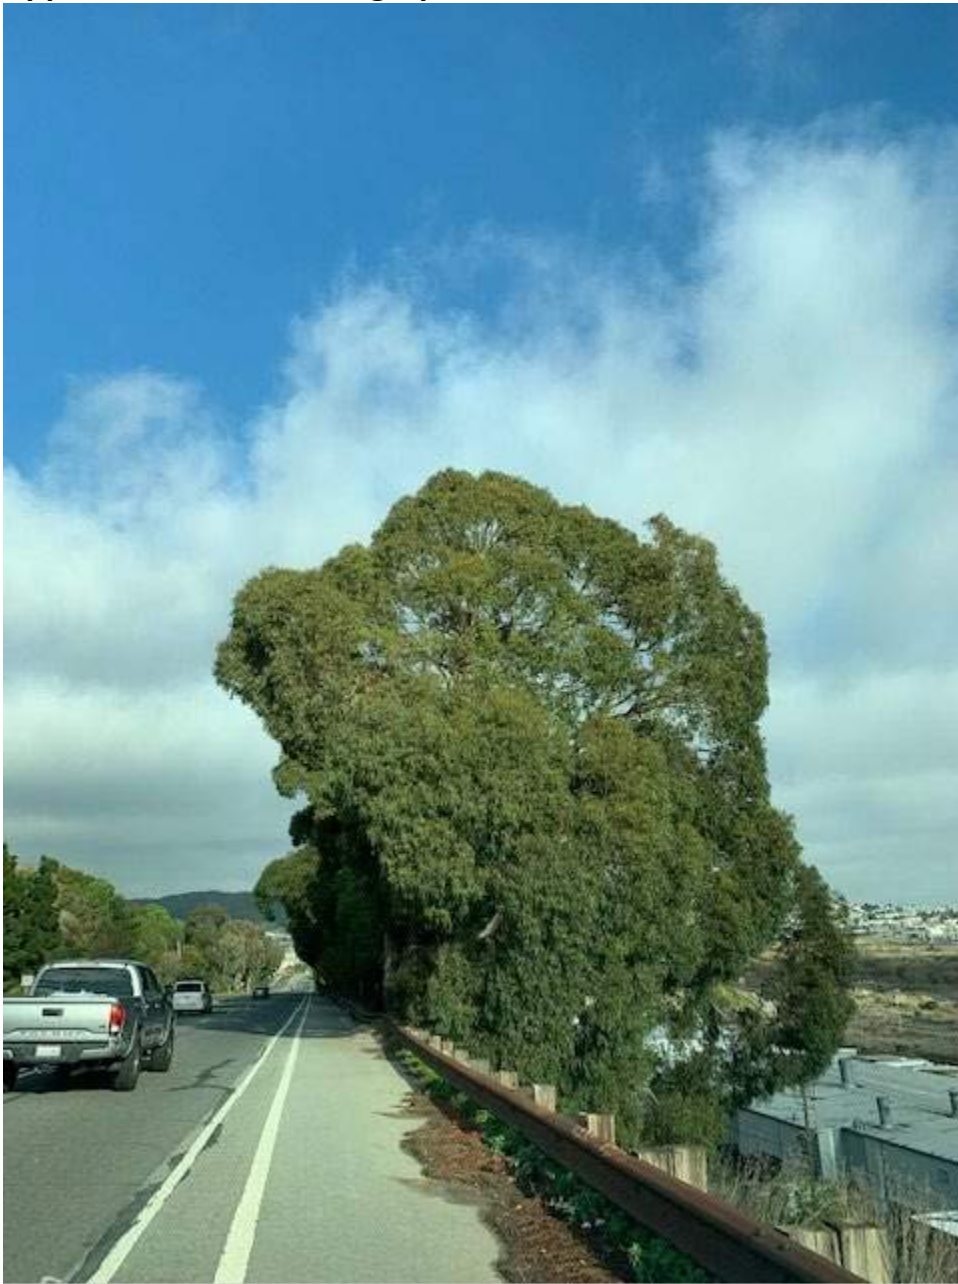
Tree 1

Tree number 1 was reported by two different sources as having been seen to be unstable in high winds at the base of the tree. Tree's 2 through 3 had been reported as having come into contact with the primary utility line and set fire during the recent storms. Tree 19 and 4 are both have codominant structures with large amounts of decay and fungal fruiting bodies forming at the main junctions of trunk near the codominance. Trees 5-18 are all located

I recommend that all of these trees be considered for immediate removal as they present an imminent danger to both persons and property.

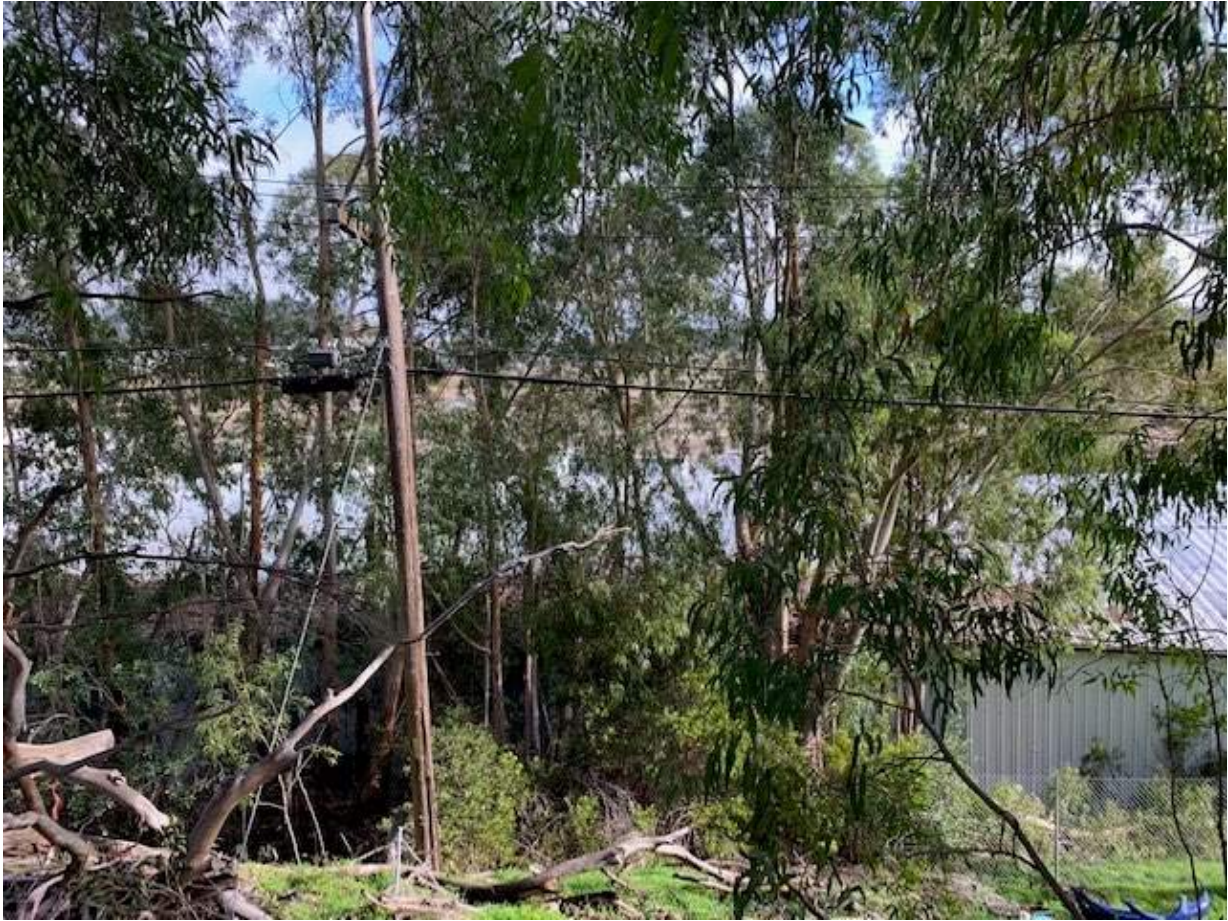
Tree 5-9

behind the warehouse at 200 Industrial Way and show evidence that they had in the past been cut down to stumps and allowed to regrow. Because all of these limbs are advantageous growth and likely more loosely attached so they present a high risk of failure.
