Subject: 400 Kings Road Slope Stability Evaluation

January 10, 2020

SUBJECT: Geologic and Geotechnical Evaluation of Slope Stability
RE: Kings Road Stability
City of Brisbane, California

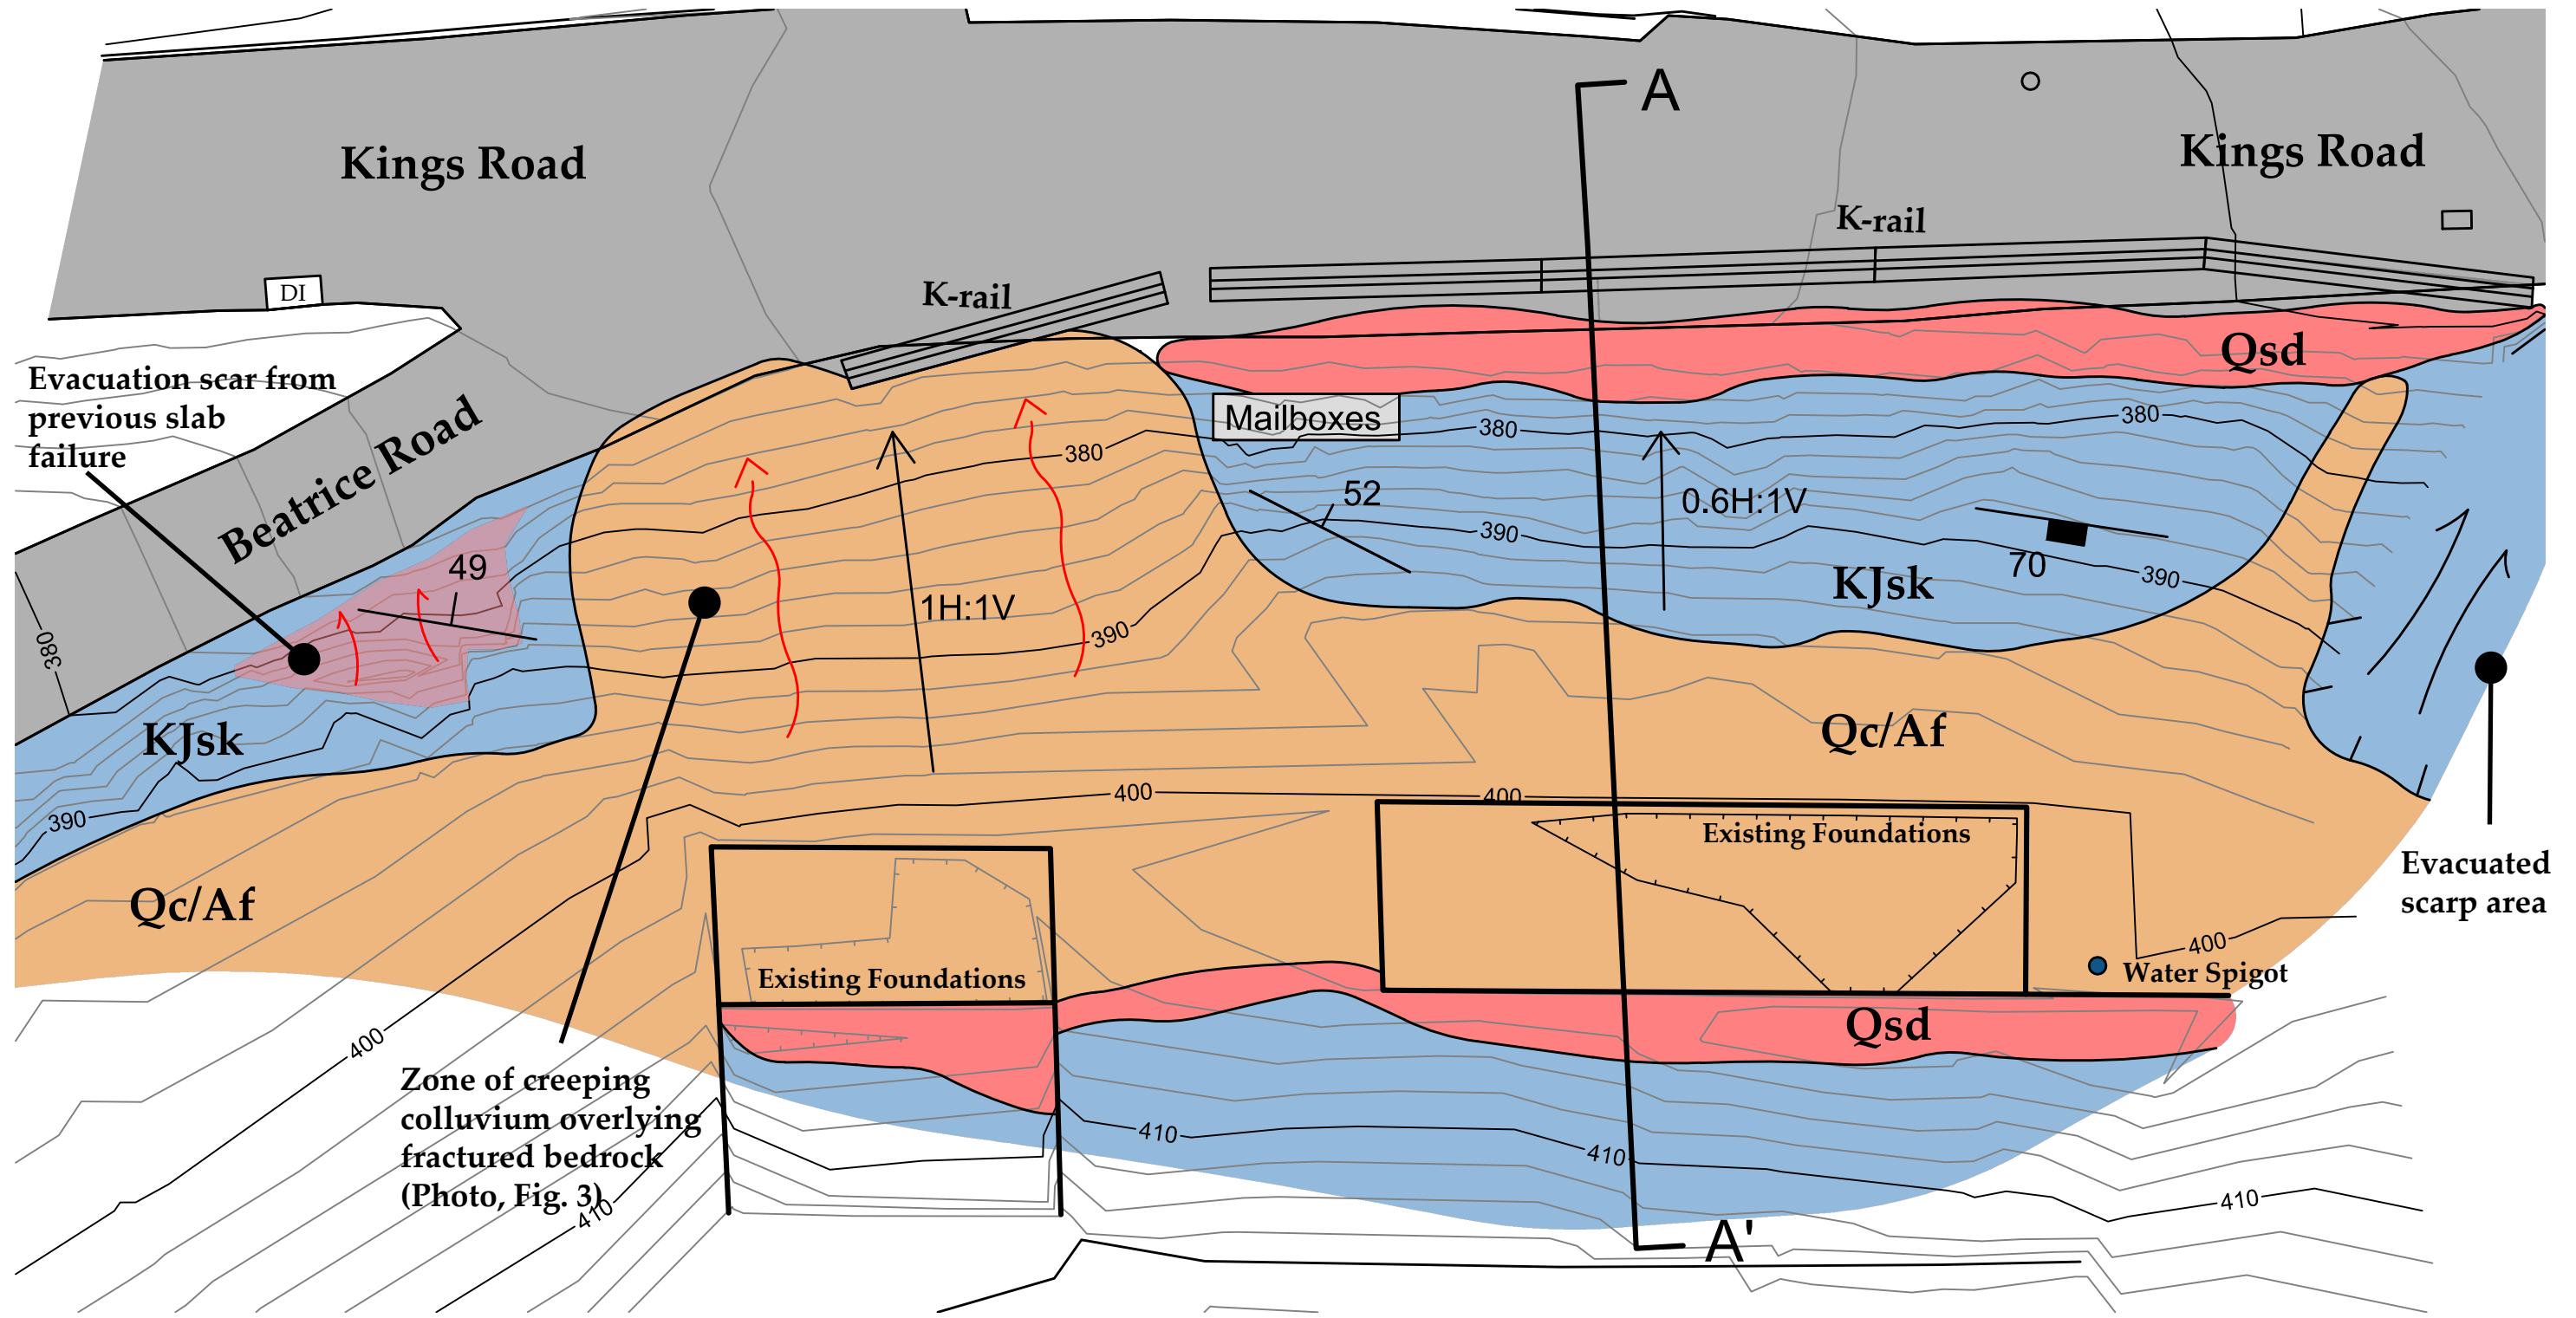
COTTON, SHIRES AND ASSOCIATES, INC. CONSULTING ENGINEERS AND GEOLOGISTS		
ENGINEERING GEOLOGIC MAP KINGS ROAD BRISBANE, CALIFORNIA		
GEO/ENG BY CS/TRH	SCALE 1"=10'	PROJECT NO. E5669
APPROVED BY DTS	DATE January 2020	FIGURE NO. 1

Based on the results of our topographic survey, the slope above Kings Road is up to 30 feet in height and is generally inclined at grades of 0.6H:1V to 1H:1V. We assume these precipitous slopes are cut slopes that were excavated during the original construction of Kings Road. Based on a review of historical aerial photographs construction of Kings Road occurred between 1930 and 1941. We observed sandstone and shale bedrock associated with the Franciscan Complex exposed in these cut slopes. The sandstone beds exposed are generally 1 to 2.5 feet thick and typically are bounded by laminated shale beds up to 1 inch thick. The in-place sandstone is moderately weathered and fractured and includes plagioclase feldspar. Roots were observed in open fractures and joints. The in-place shale was fissile, and hand samples easily crumbled. The results of our topographic surveying and geologic mapping are presented on Figure 1, Engineering Geologic Map and on Figure 2, Engineering Geologic Cross Section A-A'.

In the vicinity of Beatrice Road, it appeared that a translational slab failure had previously evacuated from the slope along a shale bedding plane (Figure 3). Concrete and steel were observed on the exposed slope that we assume were intended to retain bedrock blocks upslope of the previous failure. This failure was located upslope of the intersection between Beatrice Road and Kings Road. Surficial colluvium and artificial fill earth materials were observed at the top of the cut slope (462 Kings Road) and on portions of the slope inclined approximately 1H:1V (100 percent). Existing foundations were observed at 462 Kings Road in proximity to the top of the cut slope, and we also observed a functioning water spigot located adjacent to an existing foundation footing (Figure 1). It is unclear if this spigot may be damaged and leaking water into the subsurface.

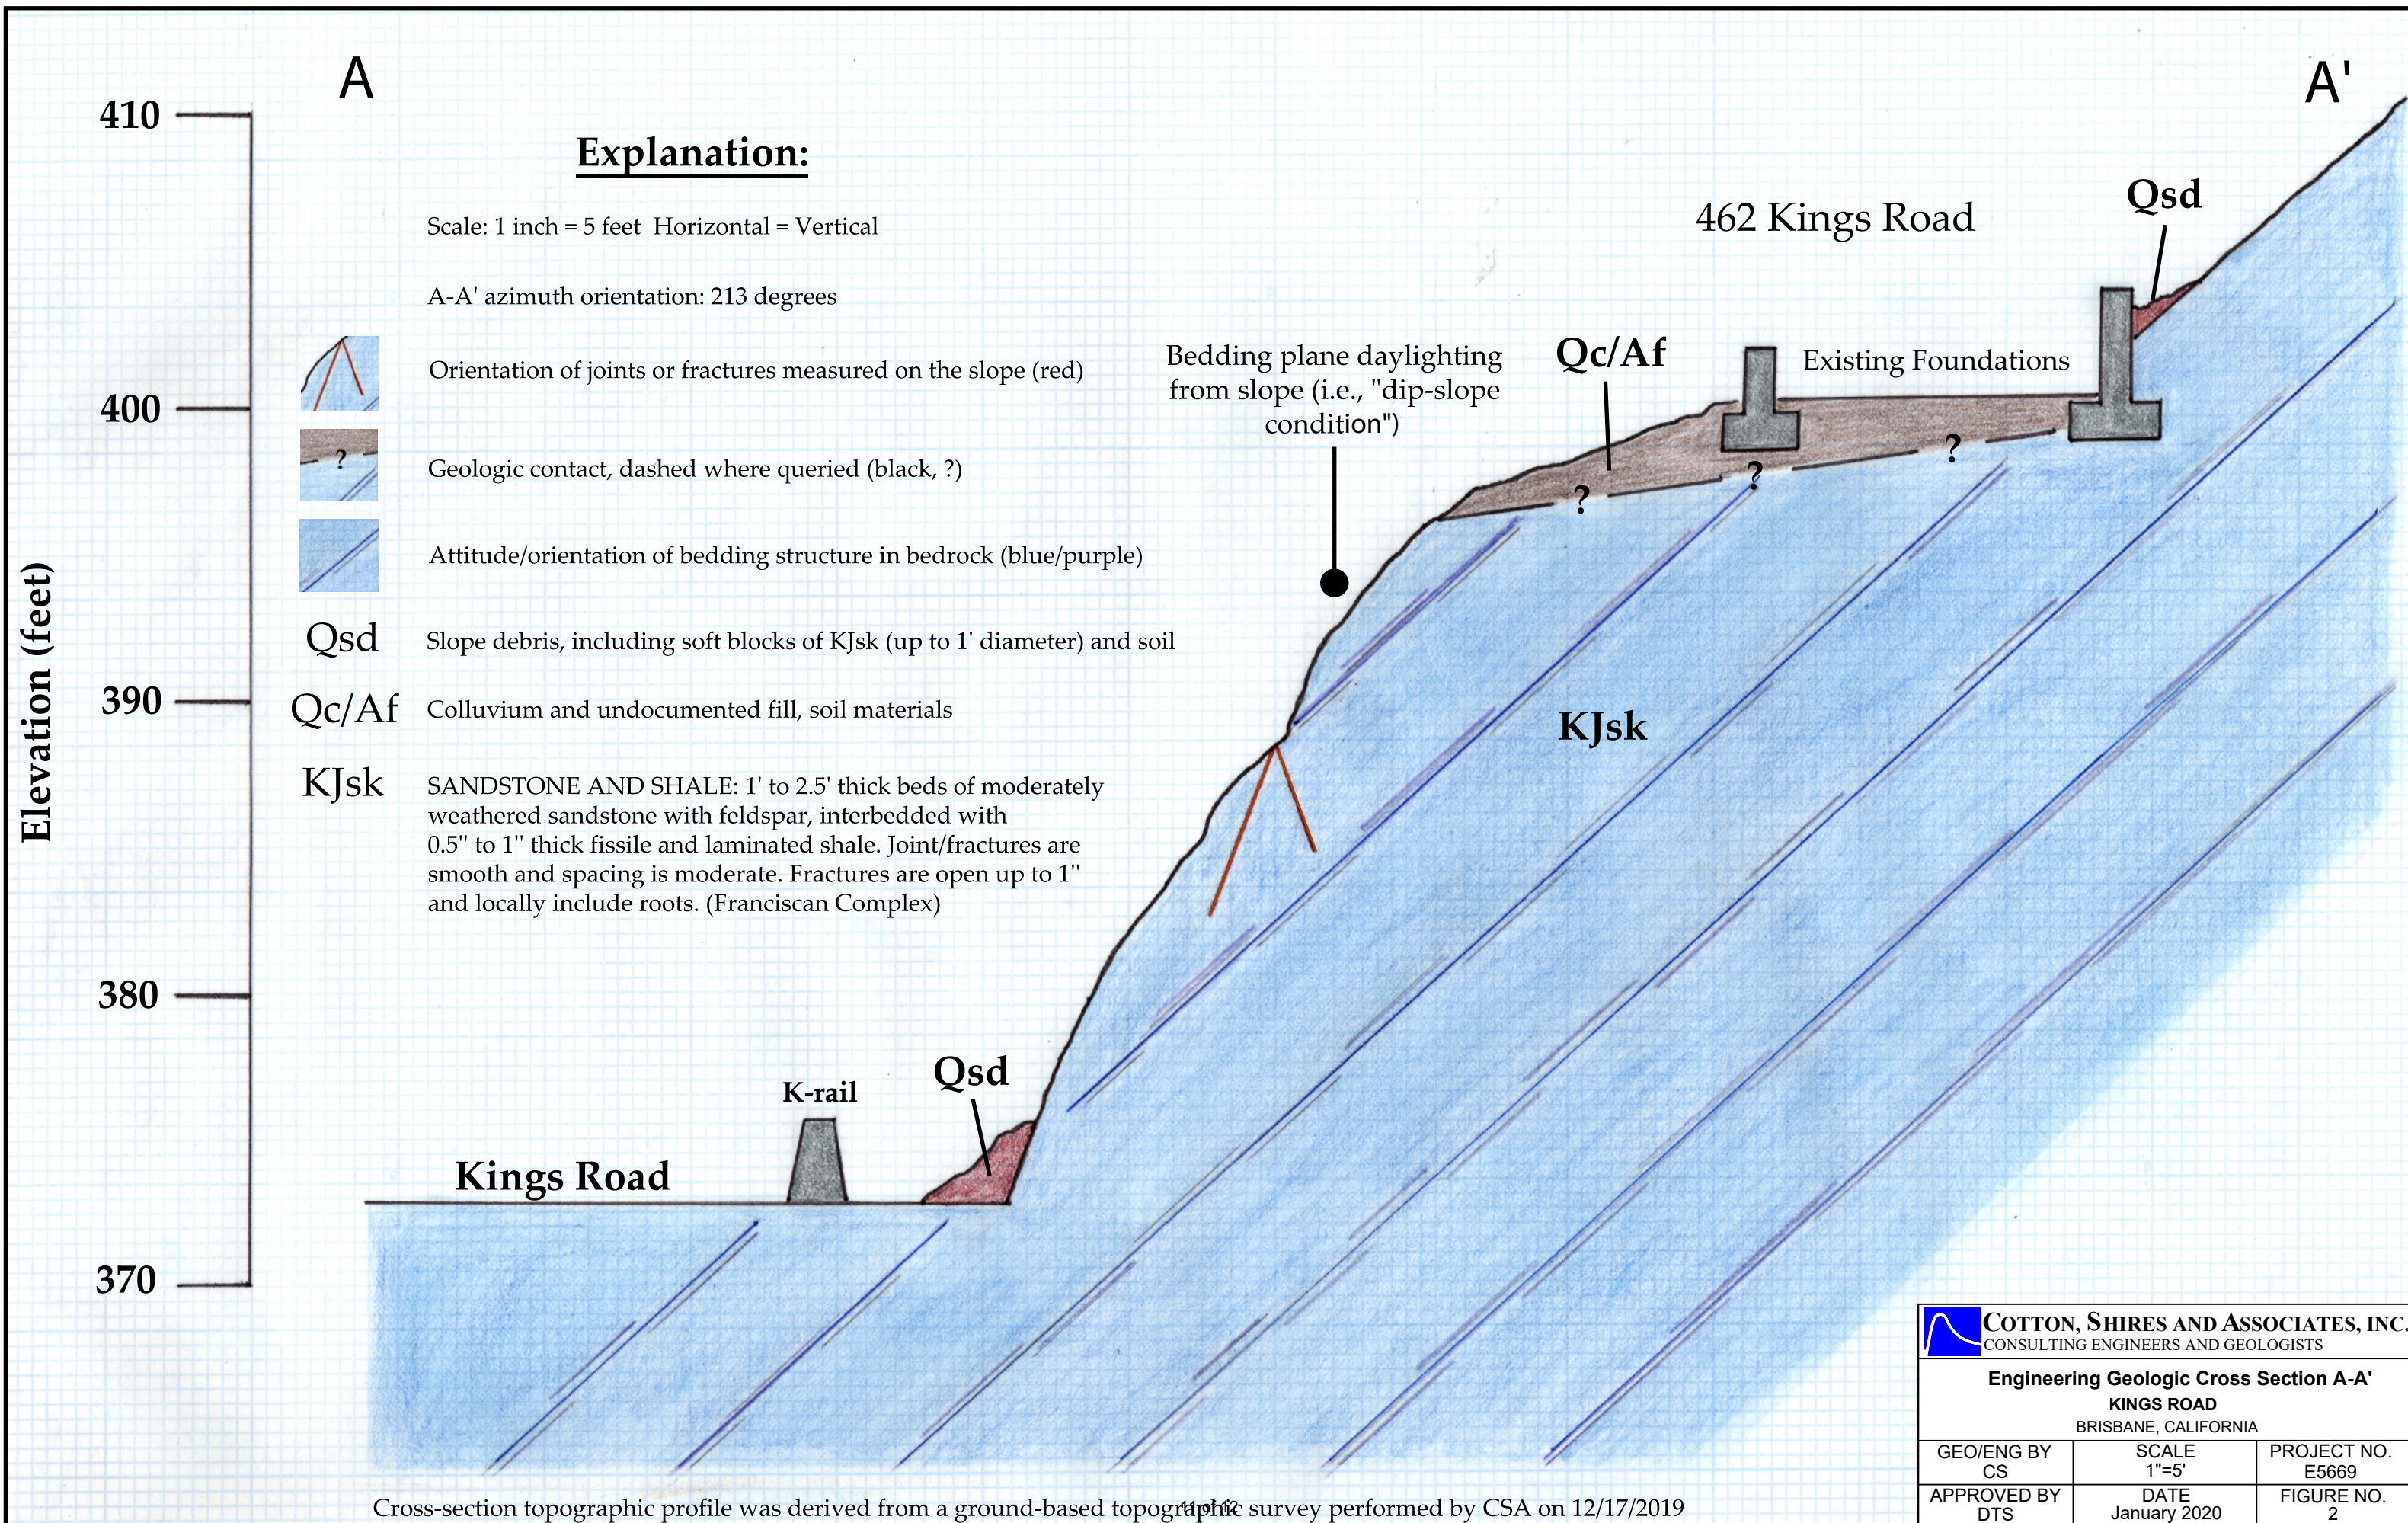
COTTON, SHIRES AND ASSOCIATES, INC. CONSULTING ENGINEERS AND GEOLOGISTS		
Engineering Geologic Cross Section A-A' KINGS ROAD BRISBANE, CALIFORNIA		
GEO/ENG BY CS	SCALE 1"=5'	PROJECT NO. E5669
APPROVED BY DTS	DATE January 2020	FIGURE NO. 2

We measured the orientations of bedrock discontinuities including bedding planes, joints, and fractures. Planar bedding orientations at the site generally paralleled the roadway (strike orientations between 311 and 335 degrees), and were dipping between 43 and 52 degrees to the northeast (towards the roadway). We note that these bedding orientations are inclined shallower than the topography of slope. This geometric configuration is commonly referred to as a "dip-slope condition" where relatively weaker geologic features (e.g., bedding planes) daylight from a slope. This dip-slope condition is illustrated on Figure 2, Engineering Geologic Cross Section A-A'. Conjugate joints were

Based on our visual observations and completed topographic survey we estimate that a significant slope failure could deposit up to 500 to 750 cubic yards of earth material on the roadway. Our estimate is based on a conceptual bedding plane (assumed failure surface) oriented at 45 degrees from horizontal that parallels the roadway and intersects the slope at the roadway elevation. A failure of this nature could 1) occur during a significant seismic event or following prolonged and/or intense rainfall; 2) would significantly impact the upslope property (462 Kings Road); and 3) would likely temporarily block the roadway, because the K-rail will not have the necessary storage capacity or lateral resistance to contain the failure.

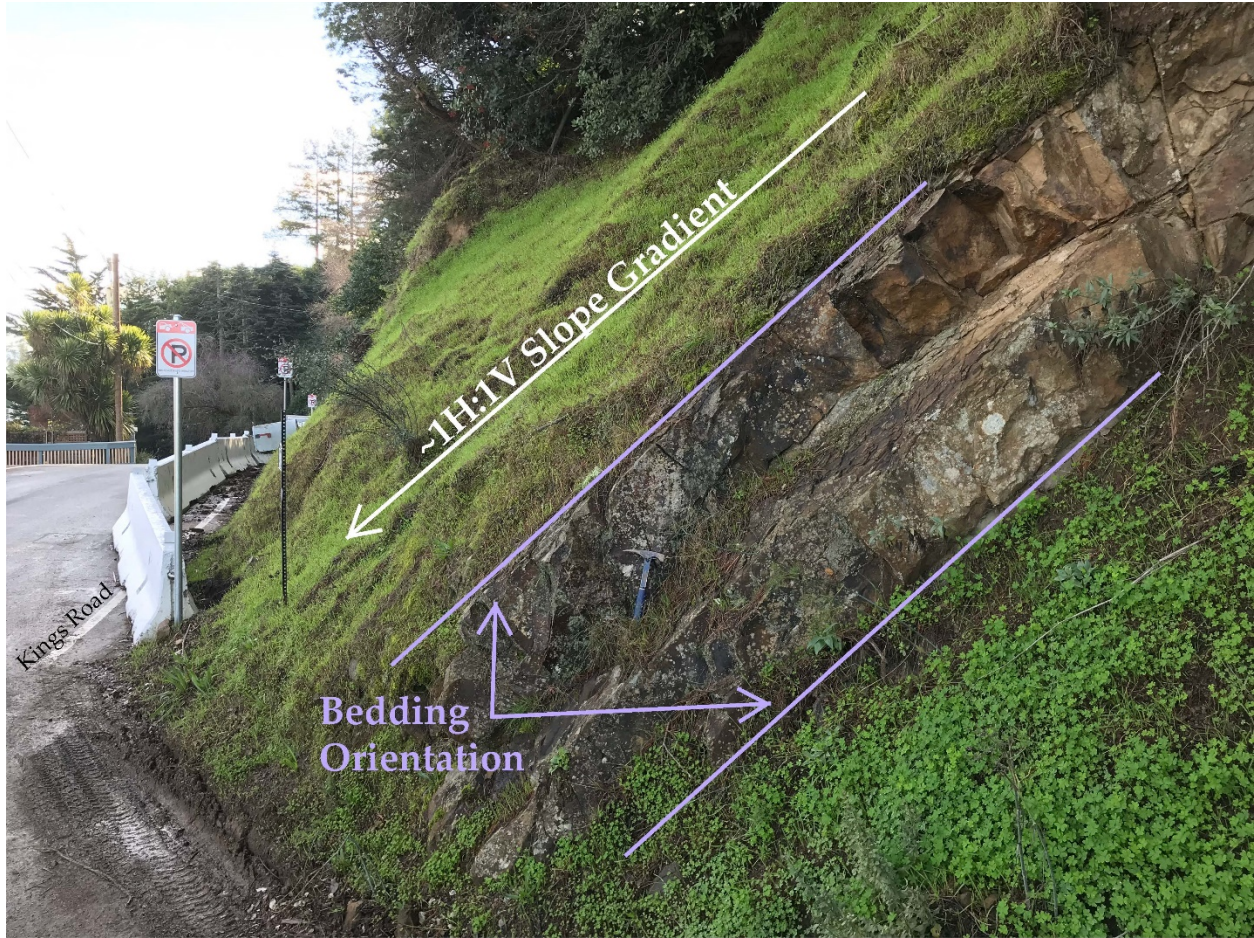
Figure 3: Photograph taken from Beatrice Road facing southeast towards Kings Road. In the fore-ground, fractured sandstone and shale bedrock of the Franciscan Complex is exposed on the slope. It appears that a previous rock-slope failure along a bedding plane (orientation annotated in purple) may have exposed this bedrock outcrop. Colluvial slopes are inclined at grades of approximately 100 percent (1H:1V Slope Gradient).
