**NOTICE OF APPROVAL OF
TREE REMOVAL PERMIT**

APPLICATION NO.: **2023-TR-8 Tree Removal**

LOCATION: **253 Kings Road**

Date: November 2, 2023
From: Ken Johnson, Senior Planner
Subject: 2023-TR-8 Tree Removal Application for Six Trees, 253 Kings Road

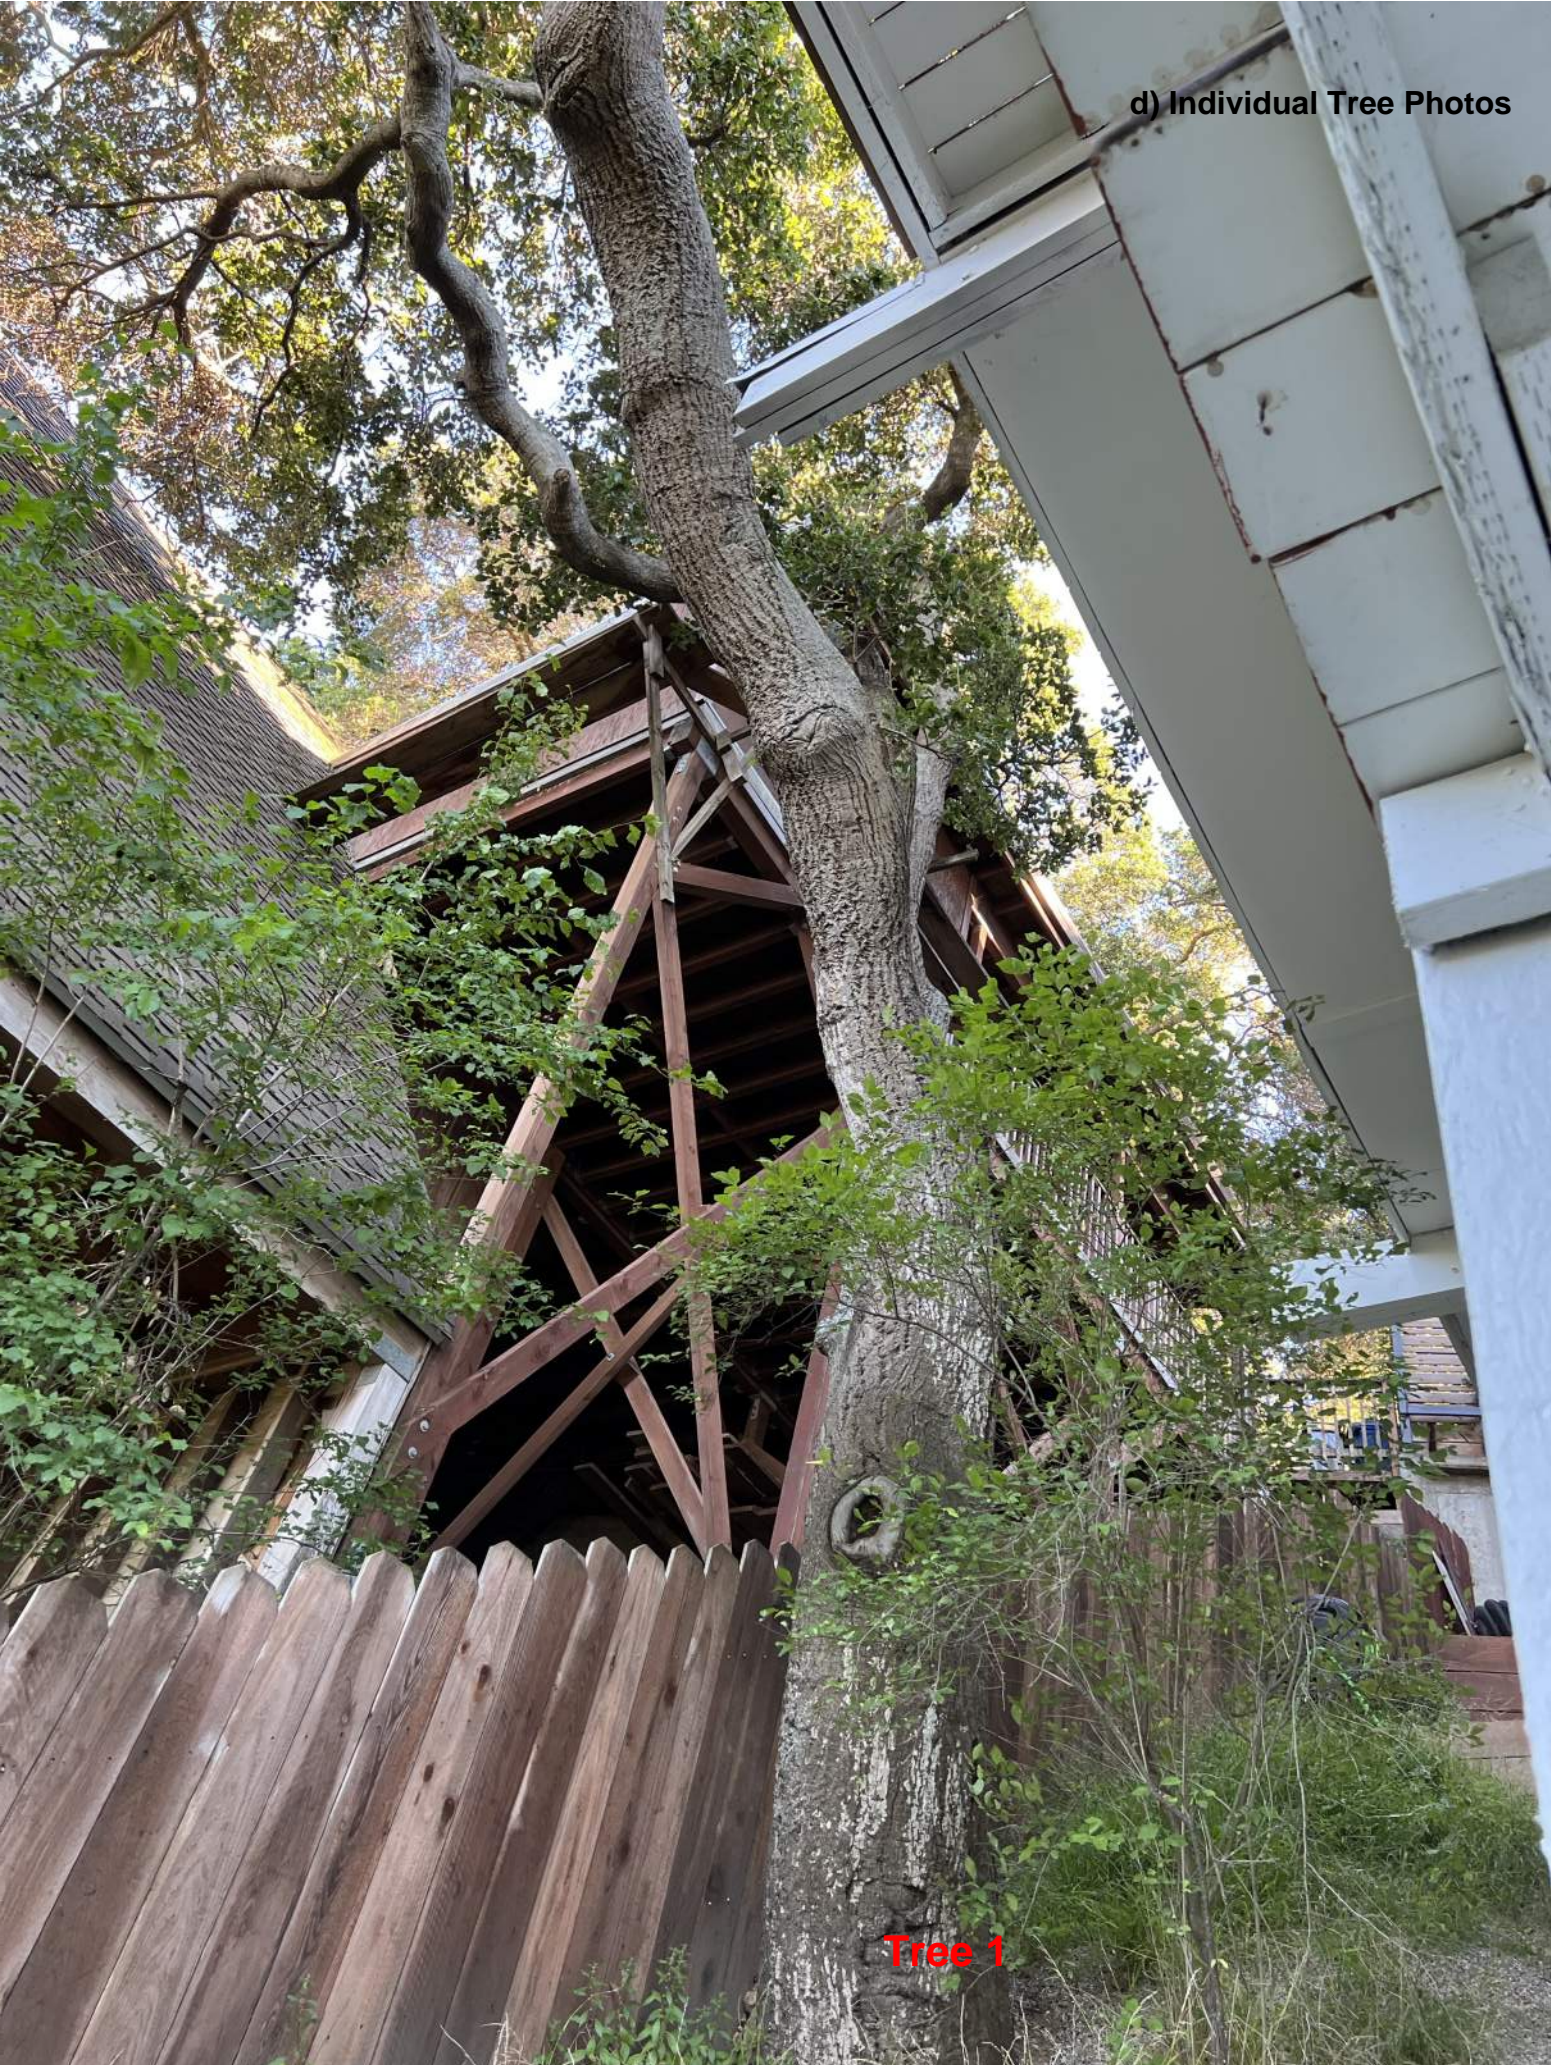
Tree 1

| Tree Identification Number | Tree Species | Summary Arborist Comments* | Finding |
|---|---|---|---|
| 1 | Coast Live Oak | Close to house, leaning and suspected of root rot. | A, B and D |

Tree Description and Arborist Recommendation: Coastal Live Oak with a diameter of 16 inches, height of 45 ft, and a spread of 45 ft. Tree is located in between the owner's house and the neighbor's house. Neighbor (Clark Conway) complains tree hits his house during high winds. Arborist report indicates tree is at increased risk of failure due to its location on a steep slope, its lean of 15-20 degrees, and its suspected tree rot. If tree were to fail it would fall onto either the property owner's or neighbor's house. Due to the factors listed arborist recommends removal of the tree.

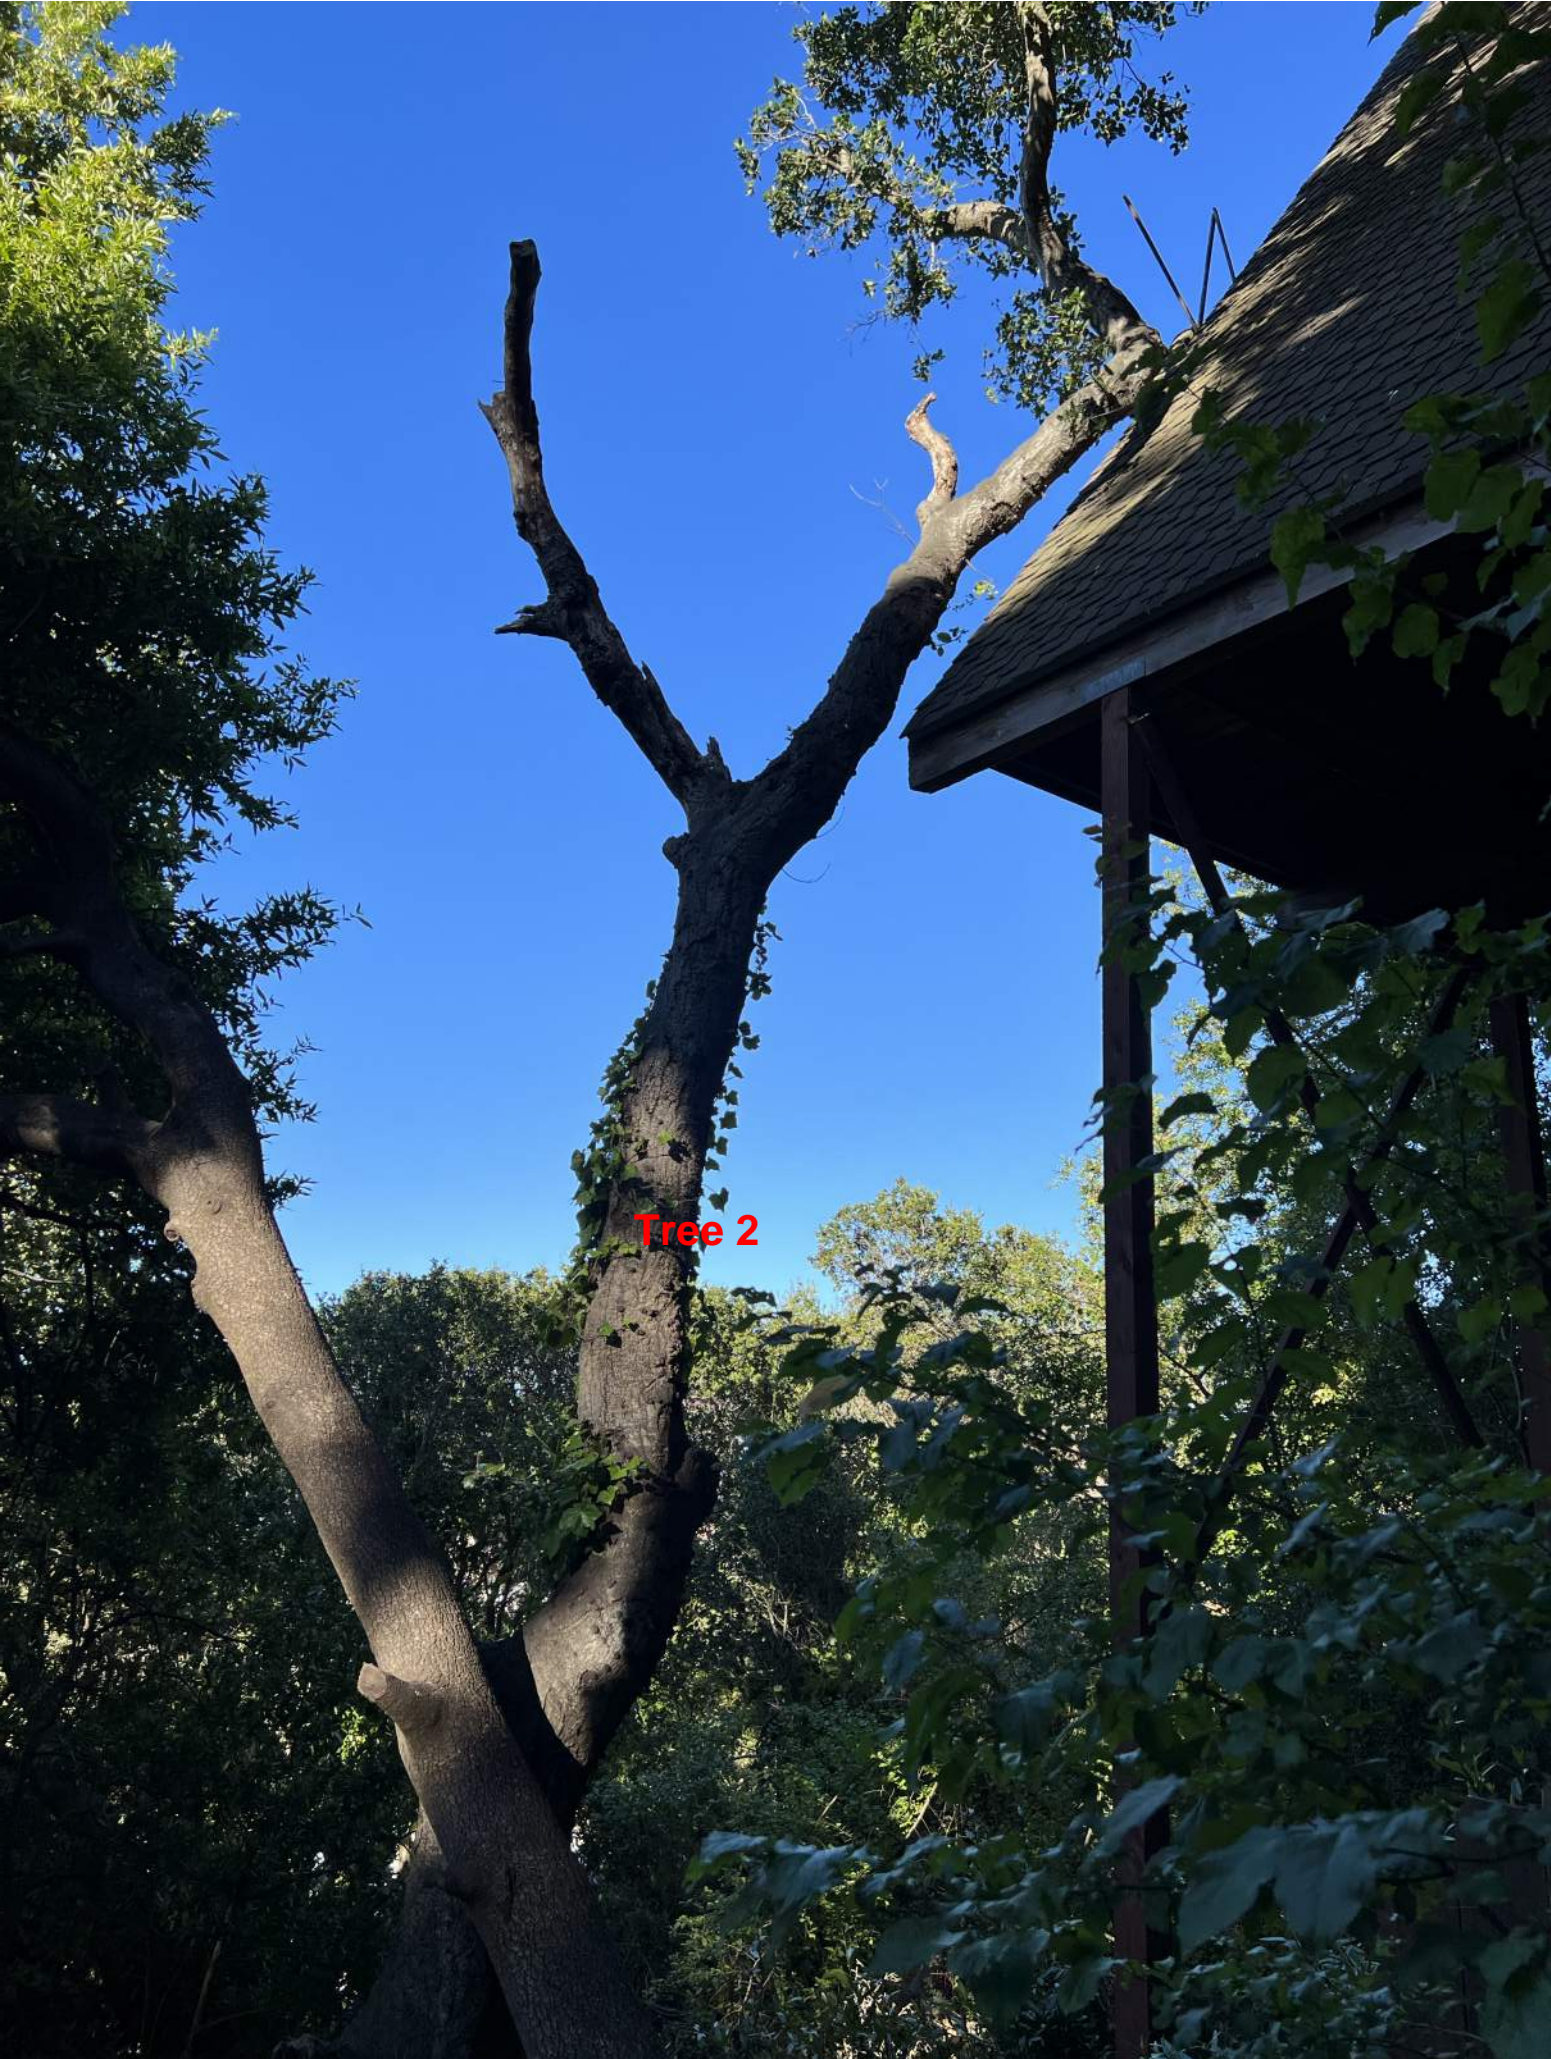
Tree 2

| Tree Identification Number | Tree Species | Summary Arborist Comments* | Finding |
|---|---|---|---|
| 2 | Coast Live Oak | Close to house, unbalanced and rot cavity on trunk. | A, B and D |

Tree Description and Arborist Recommendation: Coastal Live Oak with a diameter of 26 inches and a height of 35 ft. Tree is located on a steep hillside and is between the property owner's house and the neighbor's house. Tree has large dead branches and a healthy canopy. Tree is one sided and unbalanced, largest branch within 8-10 inches from the neighbor's roof. Neighbor (Clark Conway) complains tree hits his house during any significant winds. Tree has a cavity in the trunk at 5 ft high leading to an increased likelihood of failure. Arborist recommends complete removal of tree.

TREE #2 Oak, 26" DBH, 35' tall, on hillside and fence line with neighbor, tree has large dead branches, and healthy canopy, 1 sided unbalanced tree, large branches within 8" - 10" of neighbor's roof, cavity on trunk at 5' high, targets include nearby houses, recommend complete removal of tree, higher likelihood of failure

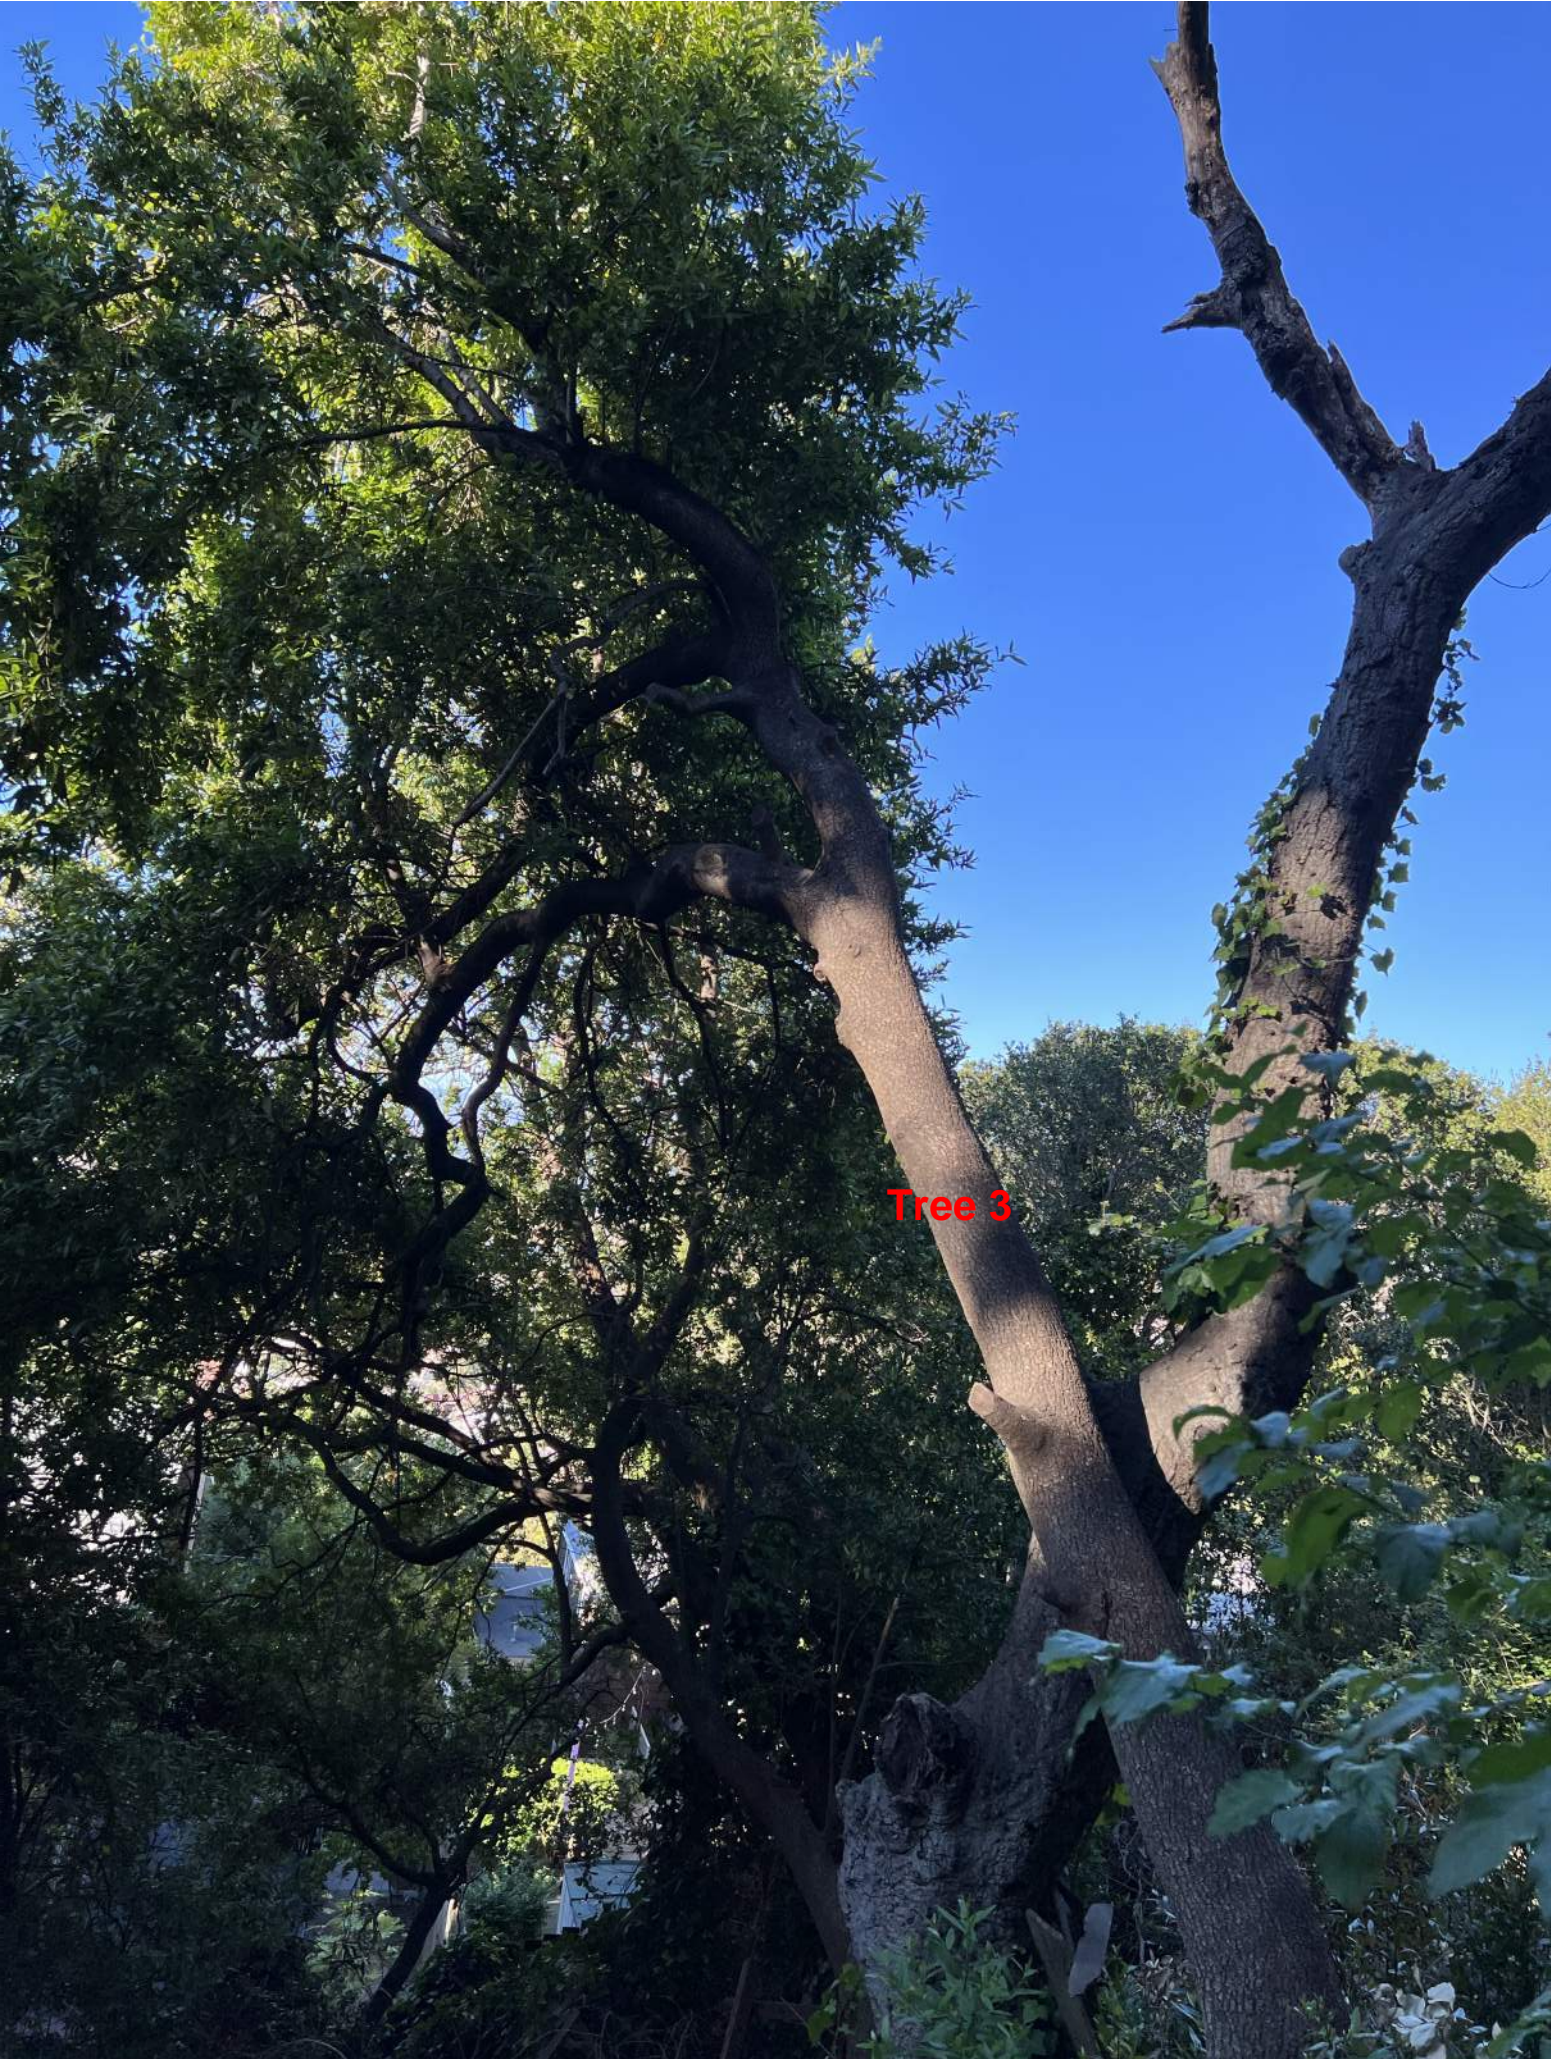
Tree 3

| Tree Identification Number | Tree Species | Summary Arborist Comments* | Finding |
|---|---|---|---|
| 3 | California Bay | Close to house, significant lean, and poor vigor. | A, B and D |

Tree Description and Arborist Recommendation: California Bay Laurel with one trunk, a diameter of 22 inches, a height of 30 ft, and a spread of 25 ft. Tree is located on a steep hillside, has a significant lean of 30 degrees, and is in close proximity to the neighbor's (Clark Conway) house. Arborist found that the tree is young, semi-mature, with sparse foliage, and poor vigor. Tree is at increased risk of failure due to its significant lean and location on a steep hillside. Arborist recommends complete removal of tree.

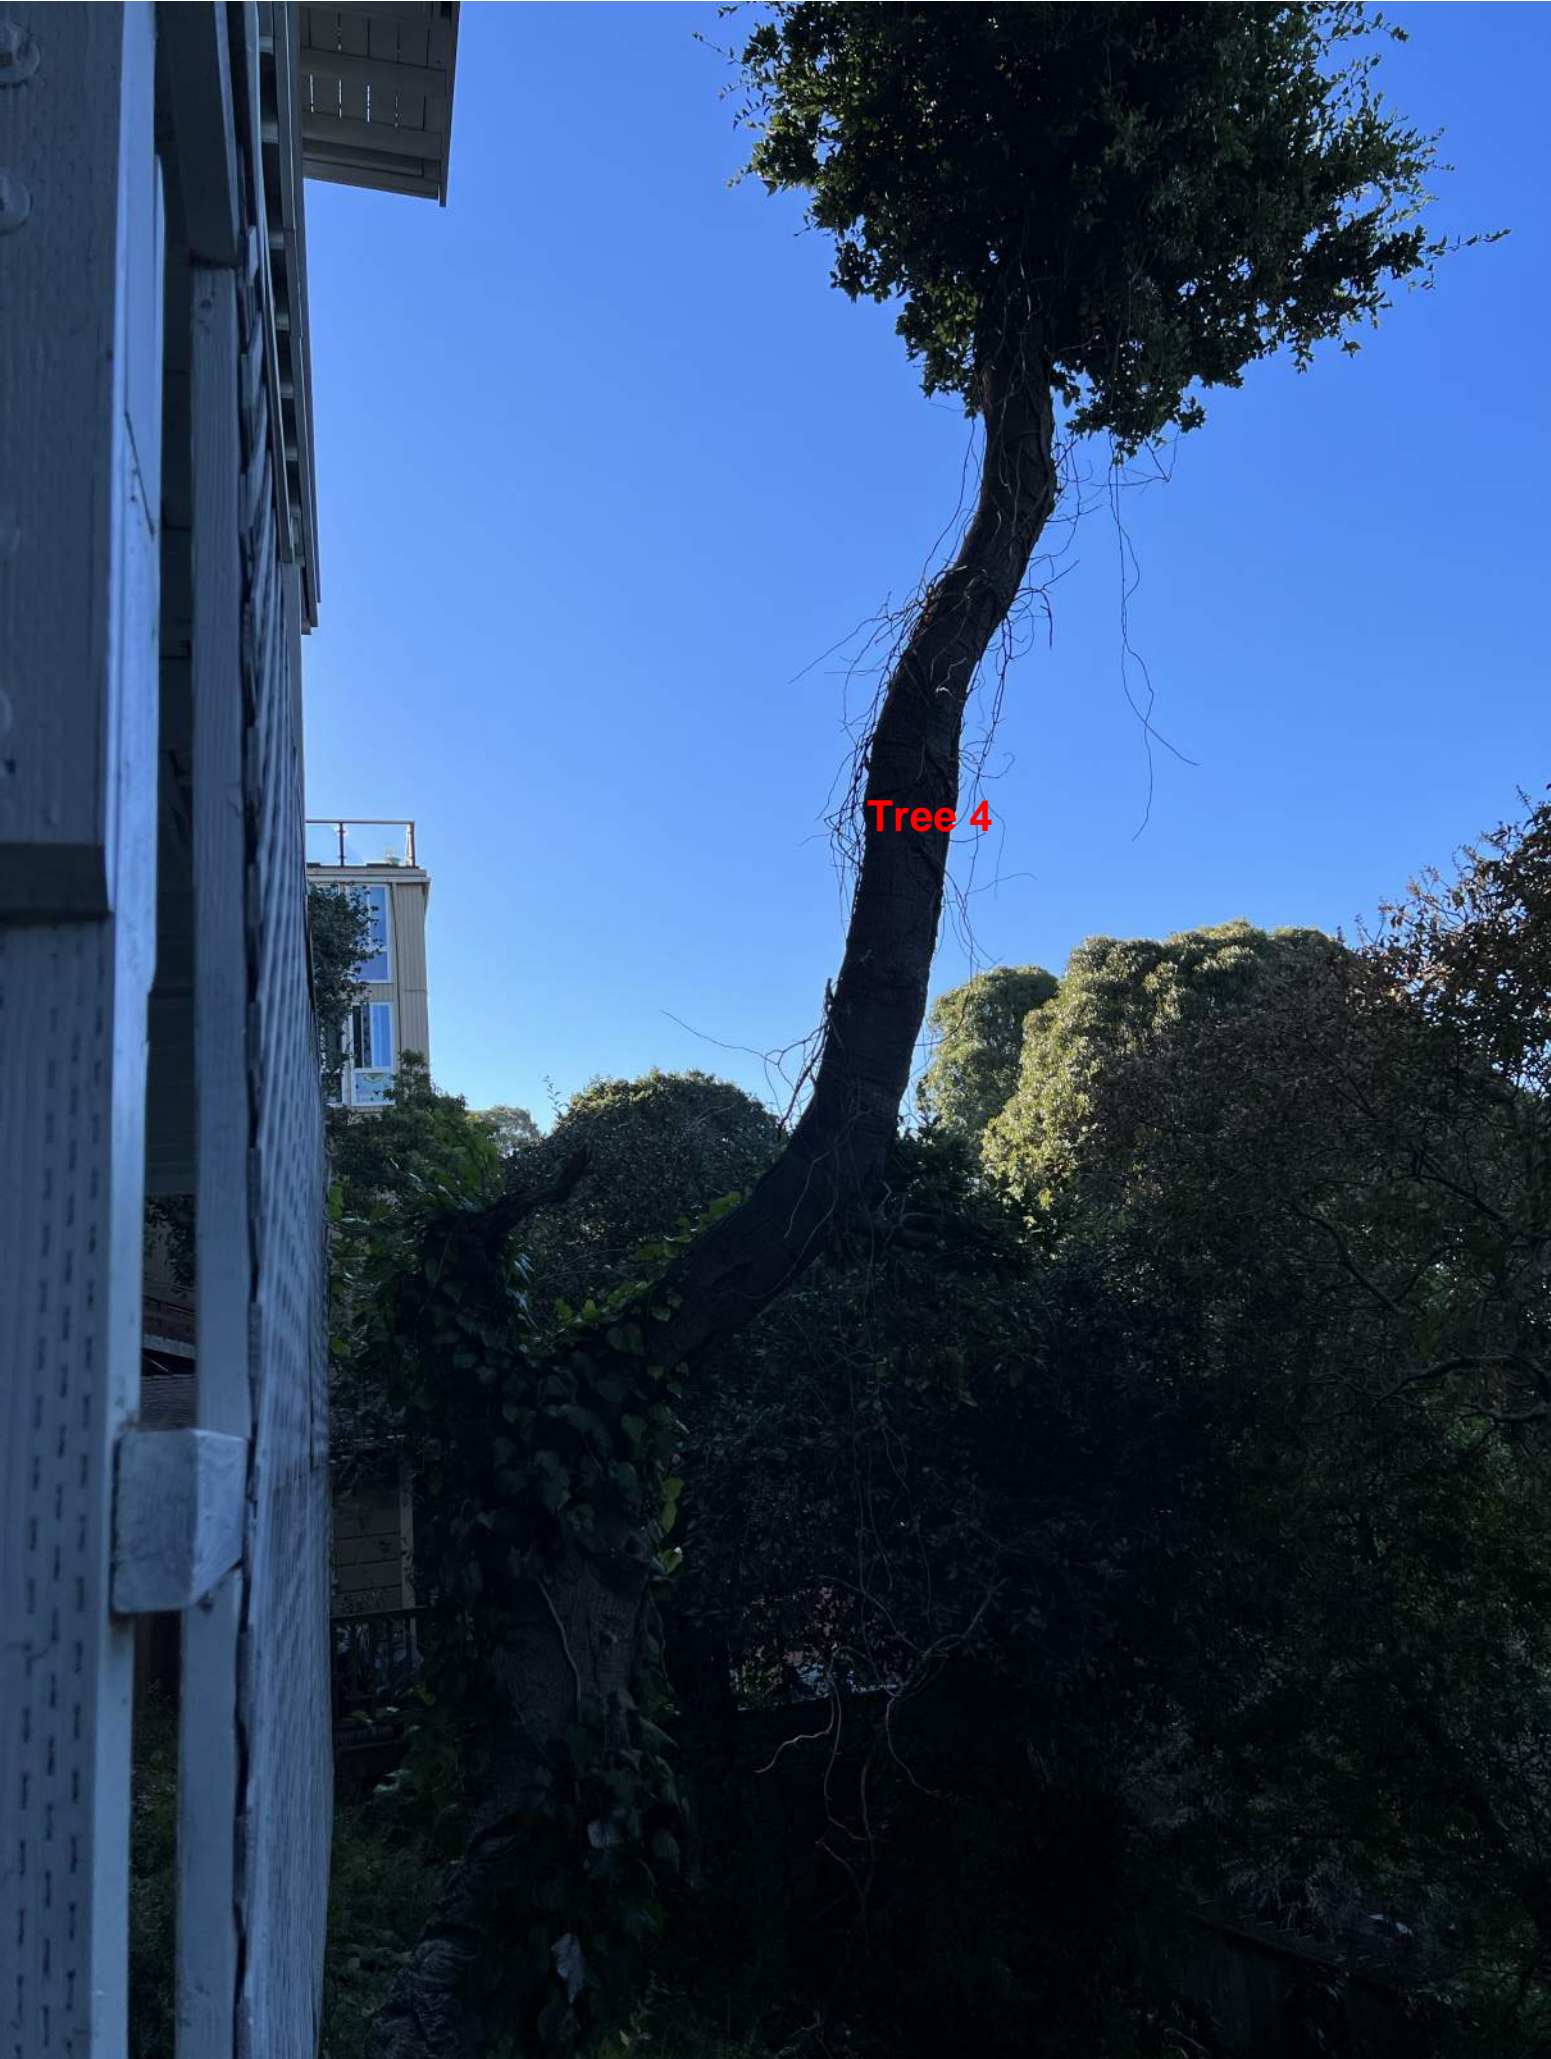
Tree 4

| Tree Identification Number | Tree Species | Summary Arborist Comments* | Finding |
|---|---|---|---|
| 4 | Coast Live Oak | Close to house, lean and severe root failure. | A, B and D |

Tree Description and Arborist Recommendation: Coastal Live Oak with one trunk, a diameter of 22 inches, a height of 35 ft, and a spread of 30 ft. Tree is located on a steep hillside, is in very close proximity to the property owner's house, and has a lean of 15 degrees. If tree were to fail it could potentially hit property owner's house. Arborist suspects root rot. Arborist recommendation is complete removal of tree.

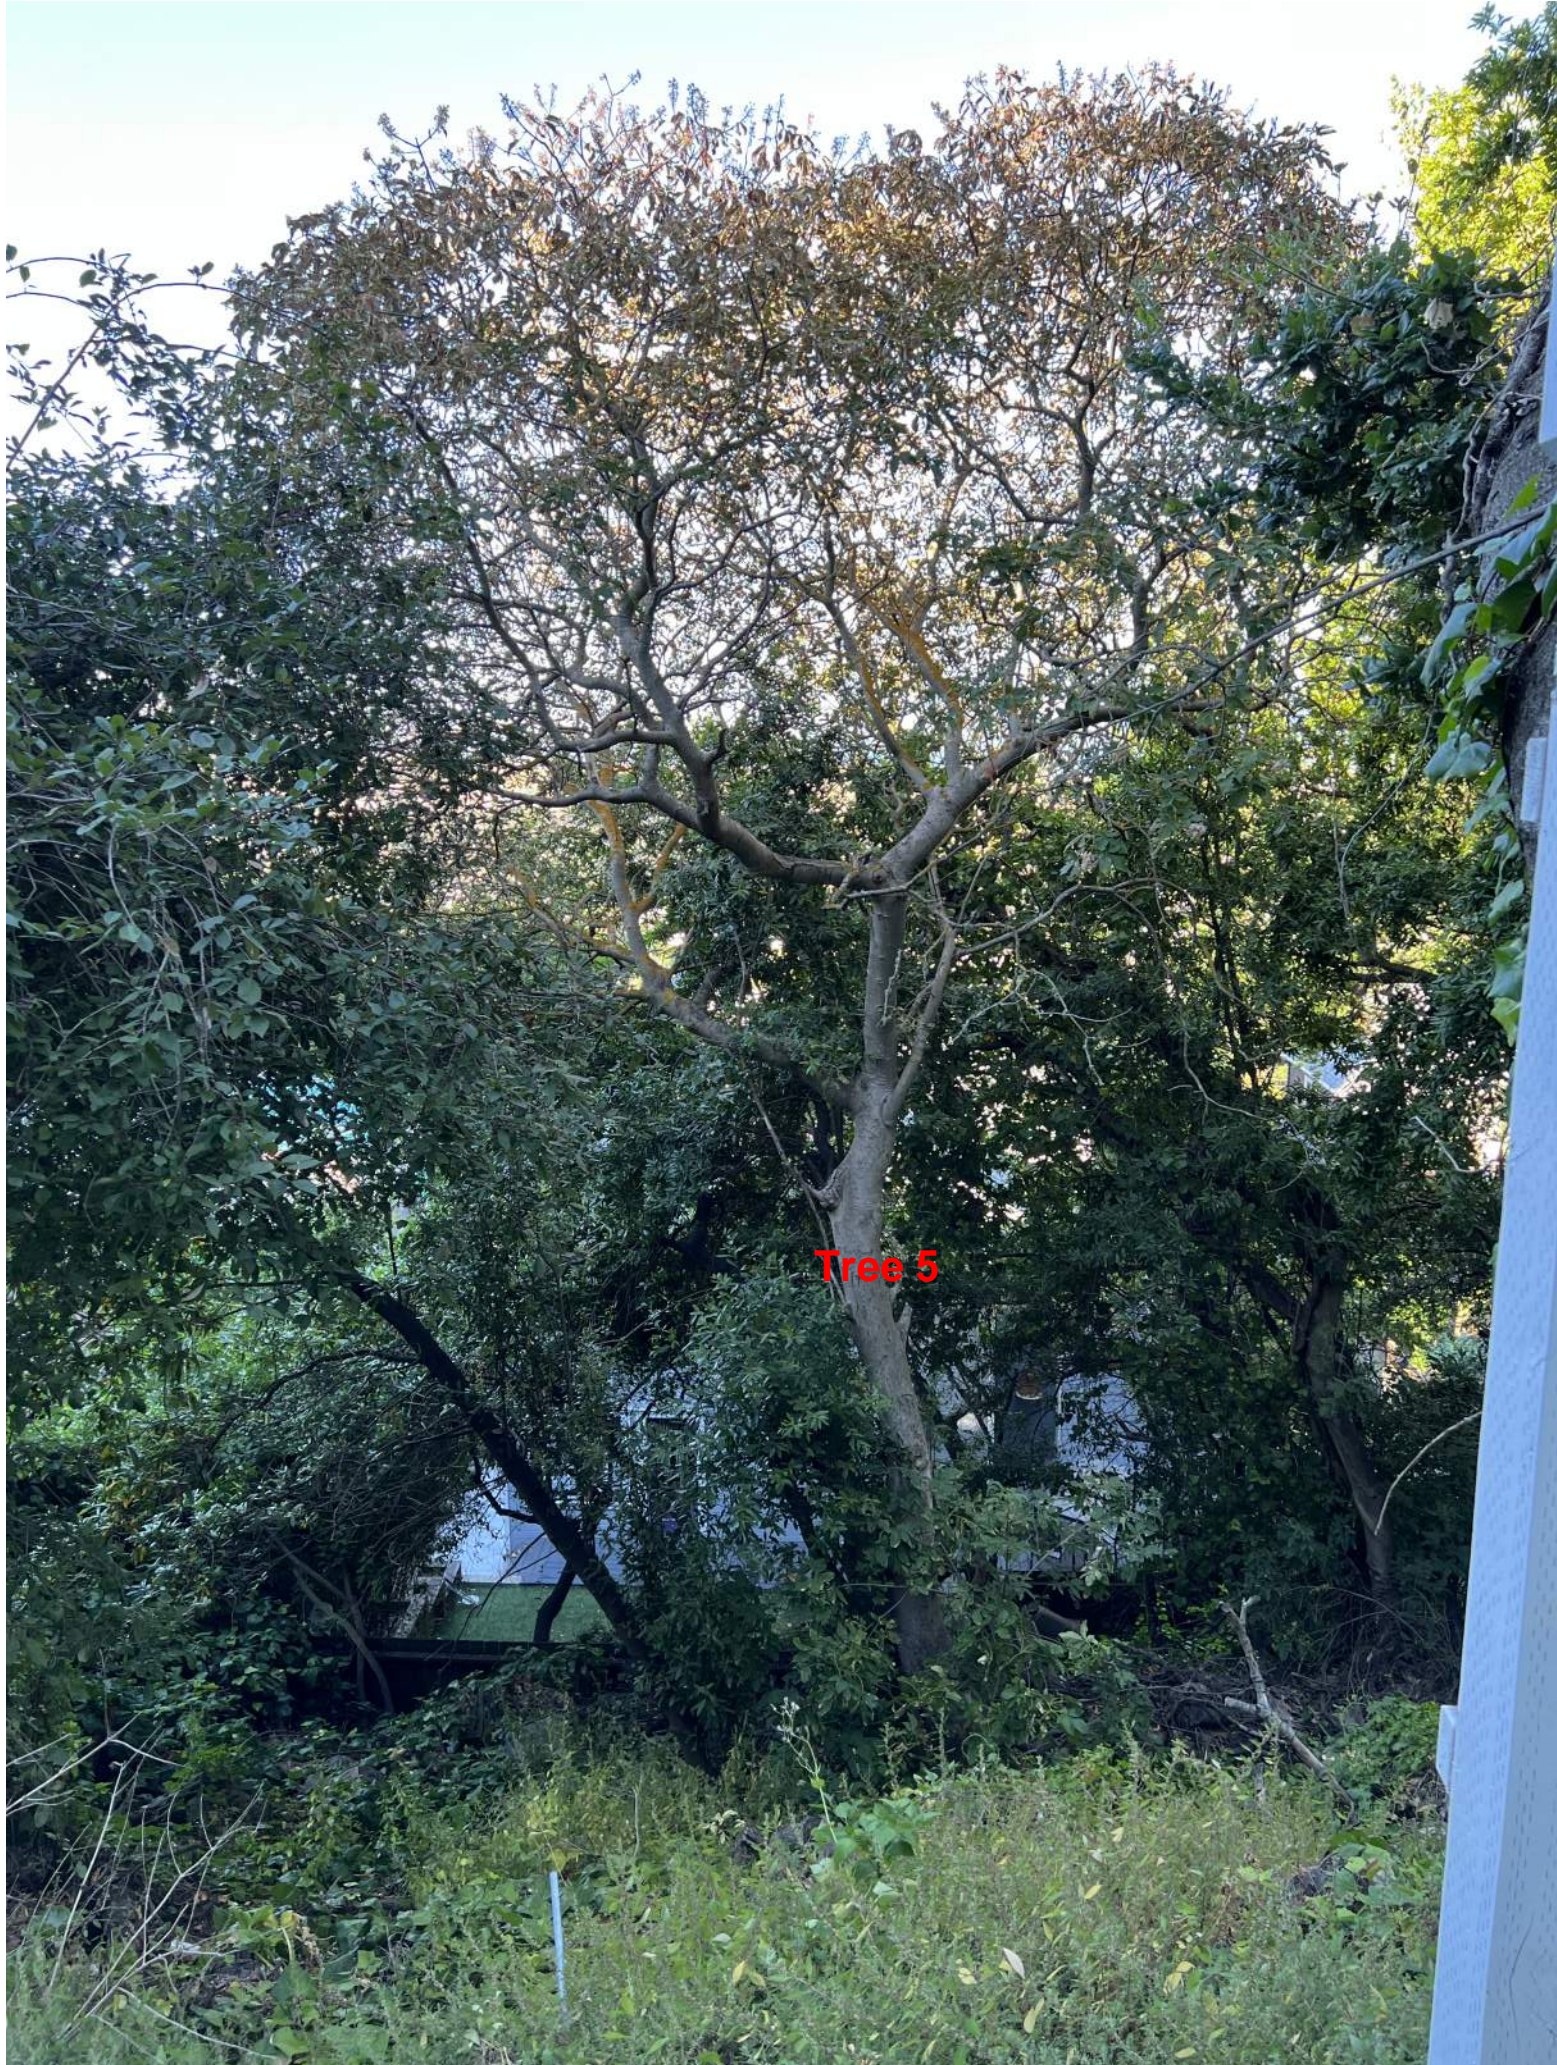
Tree 5

| Tree Identification Number | Tree Species | Summary Arborist Comments* | Finding |
|---|---|---|---|
| 5 | California Buckeye | Close to house, large dead branches, leaning downhill with risk of falling. | B and D |

Tree Description and Arborist Recommendation: Buckeye tree with one trunk, a diameter of 11 inches, and a height of 35 ft. Tree is located on a hillside, in the center of the rear yard. Tree is 80% healthy, and leans in a downhill direction. Due to the tree's lean and its location on a hillside the arborist found an increased likelihood of failure. If tree failed its primary target would be neighbor's house to the north approximately 30 ft away. Arborist recommendation is major pruning or complete tree removal.

TREE #5 Buckeye, 11" DBH, 32' tall, further down on hillside in center of rear yard, tree is 80% healthy, has some larger size dead branches, trunk is leaning in downhill direction, higher likelihood of failure, target of house approx. 30' away, recommend complete removal of tree

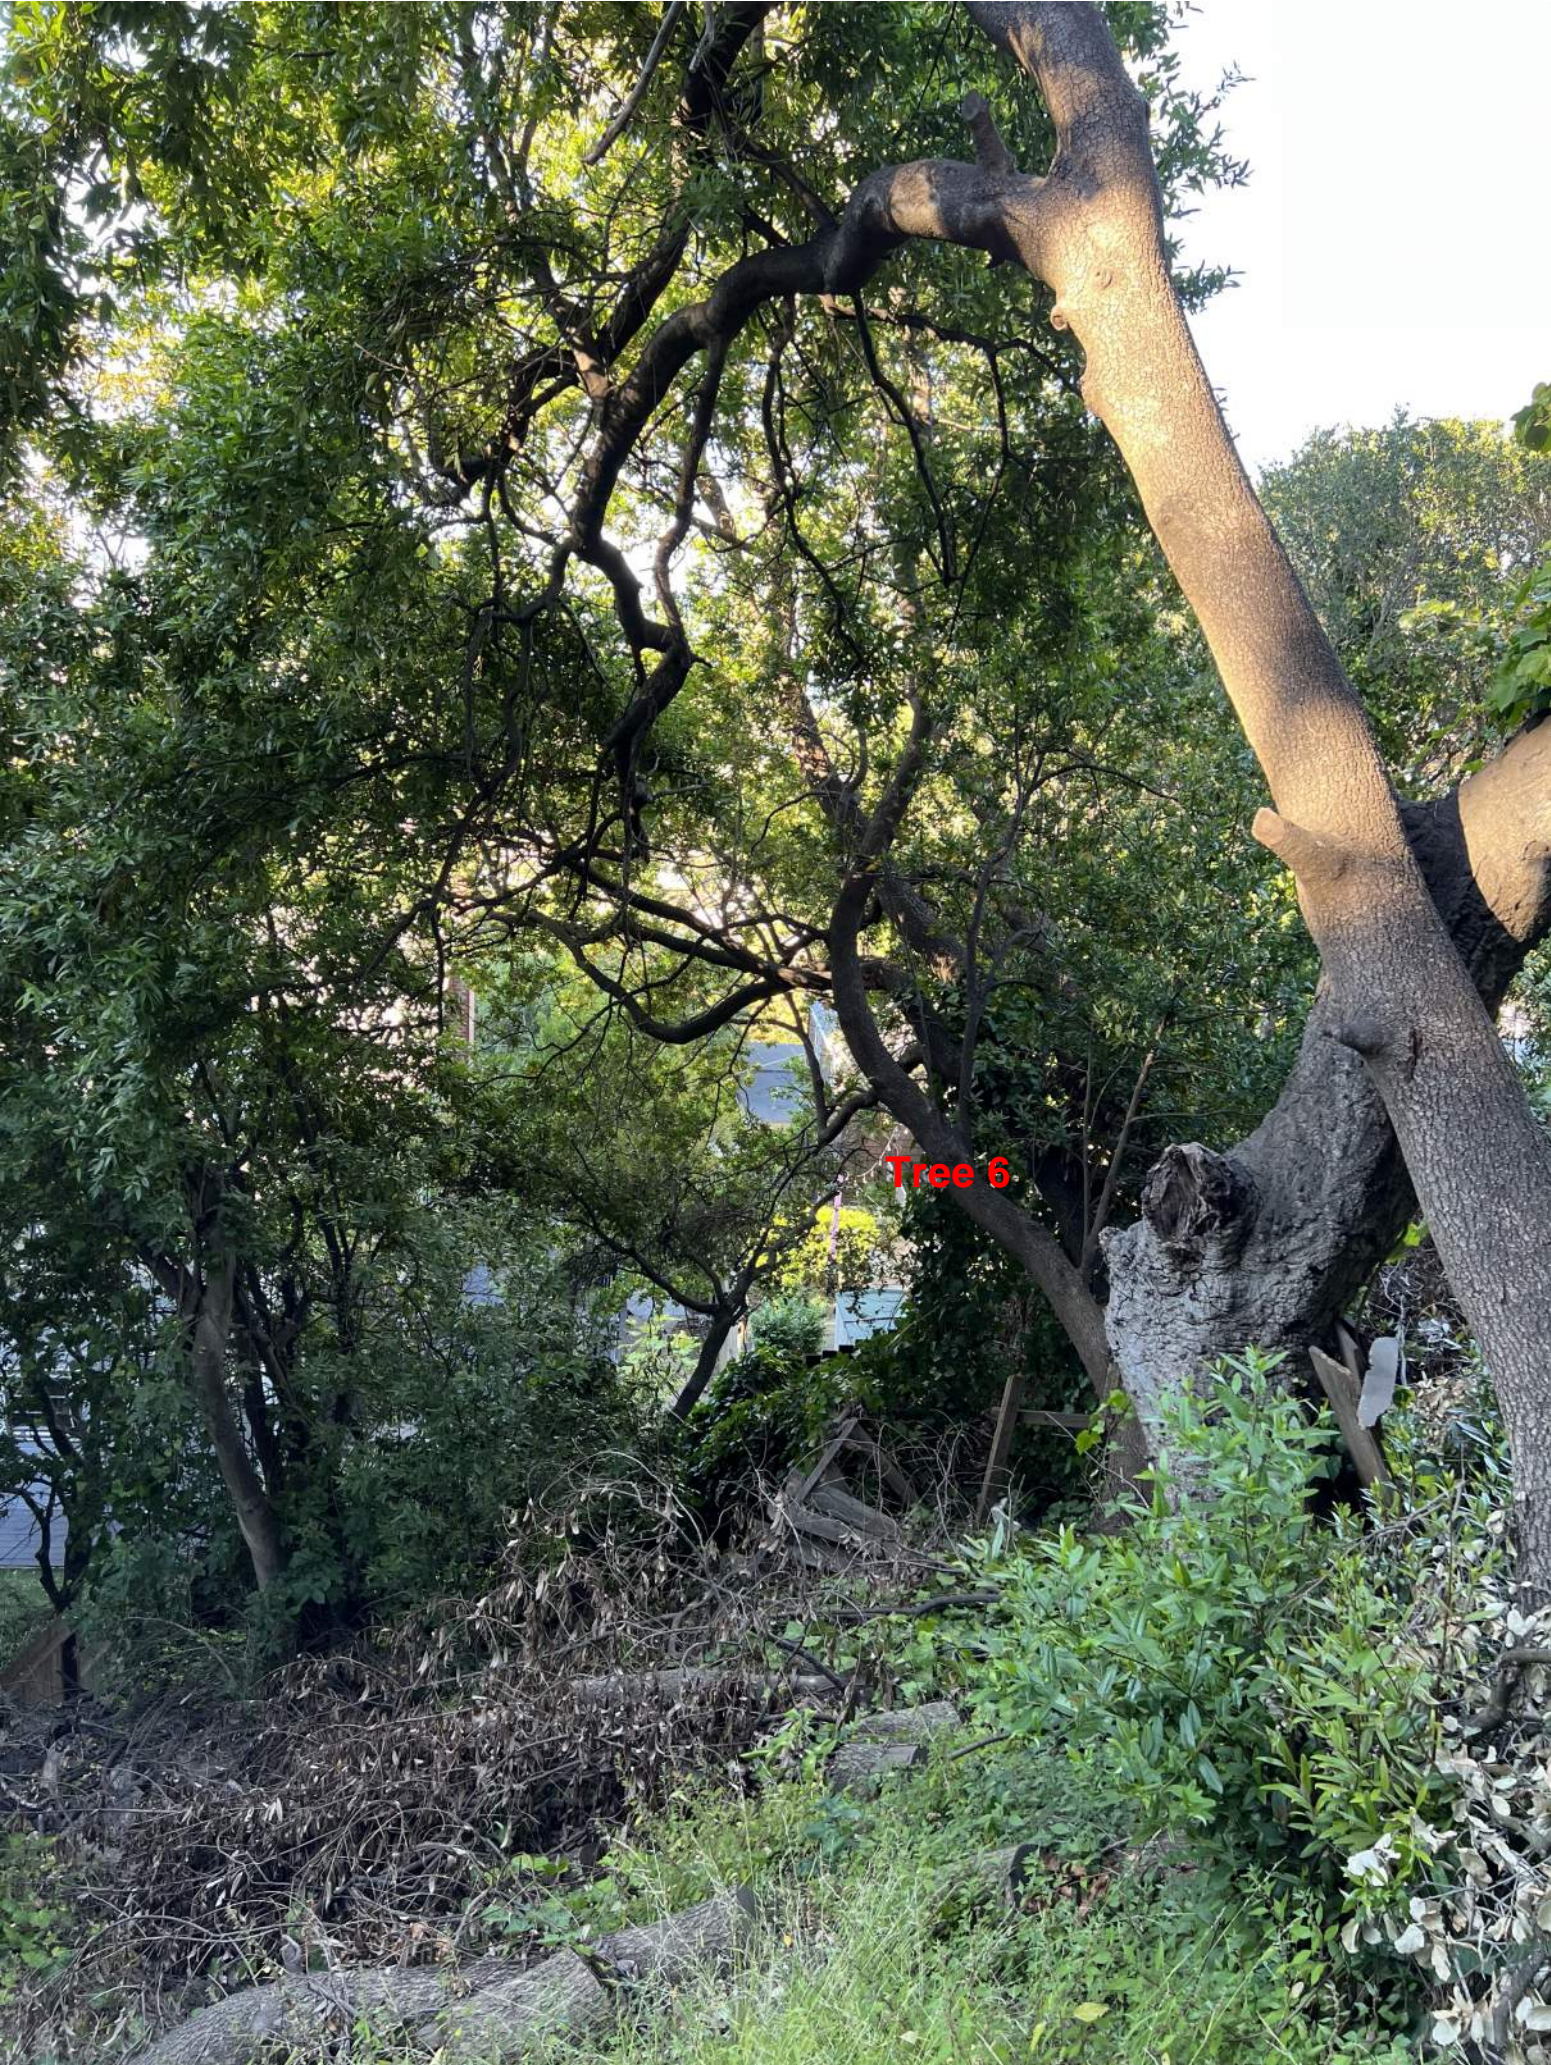
Tree 6

| Tree Identification Number | Tree Species | Summary Arborist Comments* | Finding |
|---|---|---|---|
| 6 | California Bay | Close to house, tree leans significantly downhill with co-dominant leaders. | B and D |

Tree Description and Arborist recommendation: California Bay Laurel with one primary and several smaller trunks, a main trunk diameter of 28 inches, and a height of 40 ft. Tree is located further down the hillside on the fence line with the neighbor. Tree is healthy, with significant lean in the downhill direction, and 2 co-dominant leads. These factors increase the likelihood of tree uprooting or structural branch failure, per arborist report. Targets of tree failure include houses downhill. Arborist recommends complete removal of the tree.

TREE #1 Bay, 28" DBH, 40' tall, further down on hillside on fence line with neighbor, tree is healthy, significant lean downhill direction, and 2 co-dominant leads, higher likelihood of tree uprooting or structural branch failure, targets include houses downhill, recommend complete removal of tree
