Bayshore Boulevard Hazardous Tree Survey

The Baylands Development Inc.

Baylands South Subdivision

January 13, 2022

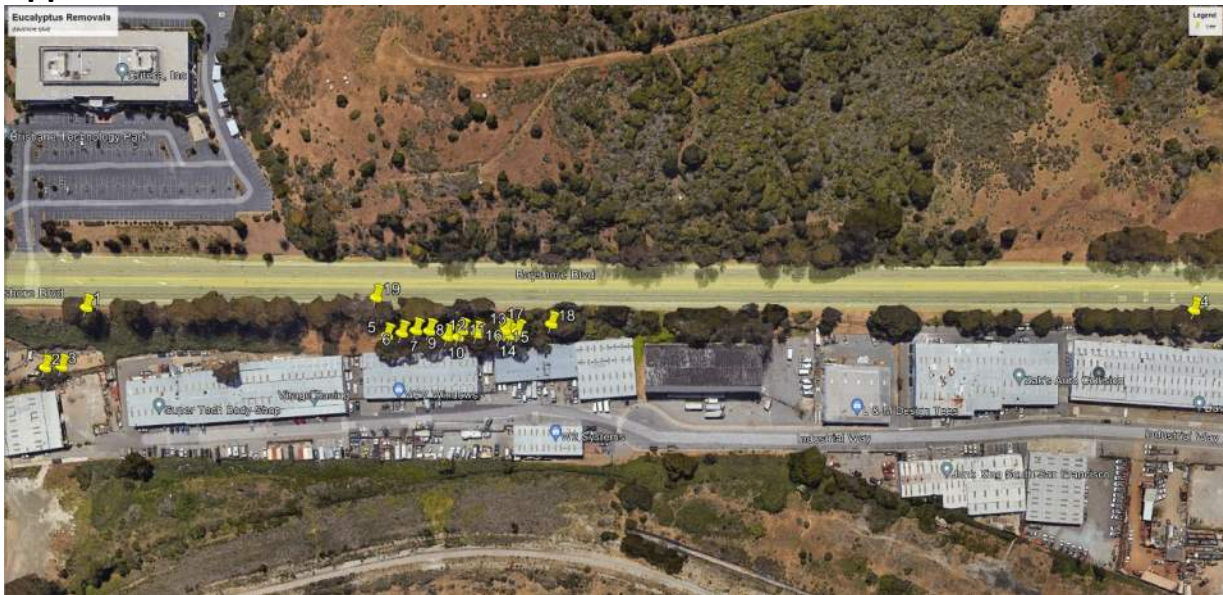
Appendix A: Site Overview

I observed on site 19 trees that presented a medium to high risk towards persons or property located along Bayshore Blvd and behind the warehouses located along Industrial way. (Appendix A: Site Overview)
