## CROCKER PARK RECREATIONAL TRAIL MASTER PLAN

## City of Brisbane Crocker Park Recreational Trail Master Plan

### **EXECUTIVE SUMMARY**

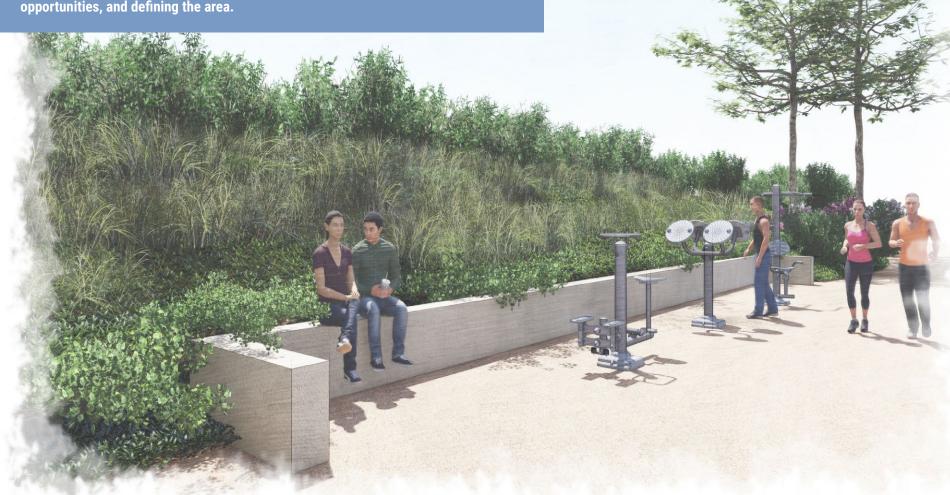
#### **FITNESS STATION**

Fitness stations will have multiple functions. There are different types of fitness equipment, both static and kinetic, and there is also flex space to do workouts without equipment.

Additionally, a wall will surround the space working as a retaining wall, seating opportunities, and defining the area.

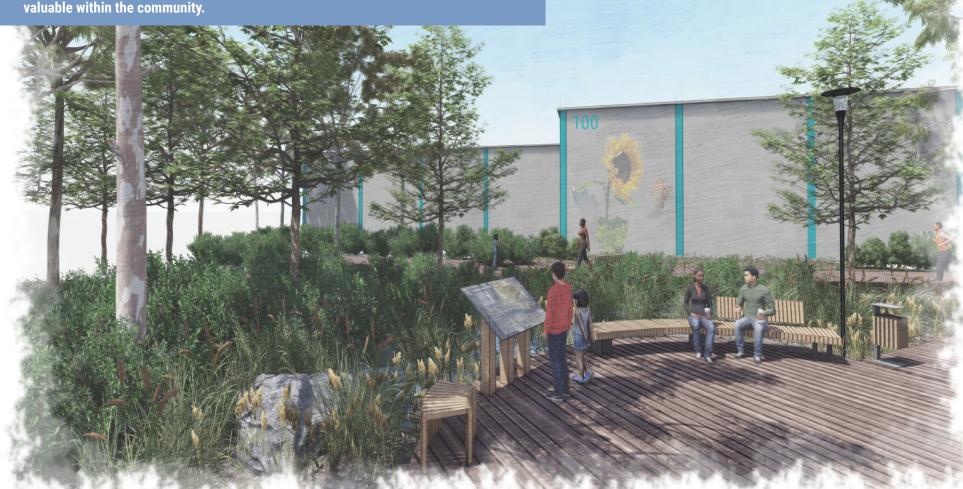
#### HABITAT ENHANCEMENT NEAR CYPRESS LANE

Educational opportunities present themselves when the potential wetlands flourish with the pseudacris regilla, commonly known as the Pacific Chorus Frog. Crocker Park users can learn about the sensitive environment around the trail through educational signage. The lifted serene seating areas also allow for observation above the habitat region. These experiences and knowledge about habitat preservation are extremely valuable within the community.

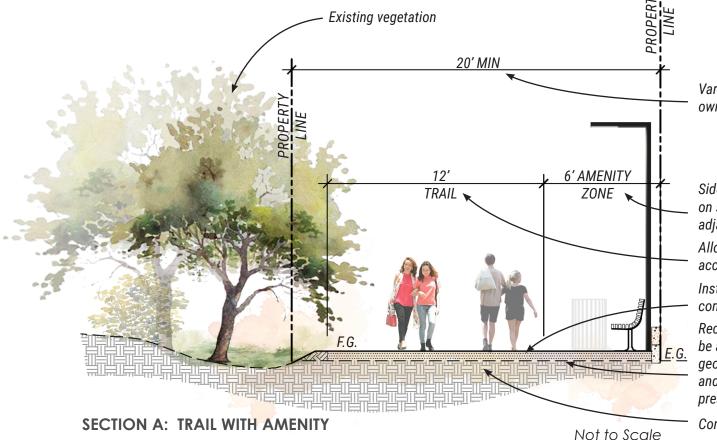
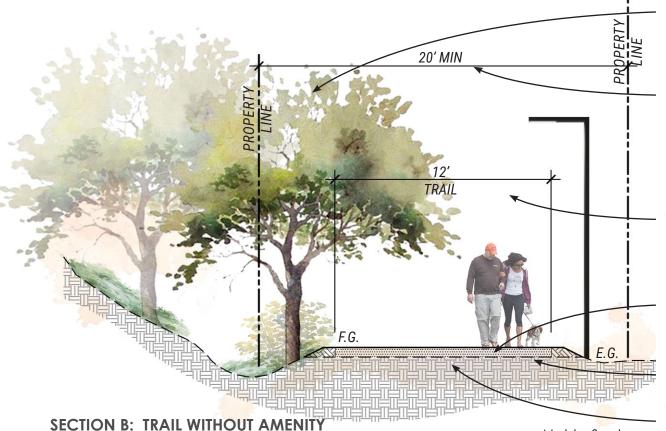
Varies throughout corridor based on City owned property.

Side of trail varies throughout corridor based on specific grades, biological restraints, and adjacencies.

Allows for maintenance and emergency vehicle access

Install 6" crushed fines in two (2) lift and compact to 90% relative density.

Recommendation: Underlying soils need to be analyzed to determine if placement of a geotextile is needed based on soil suitability and where drain rock may be required to preserve historical drainage patterns.

Compacted subgrade in place

Opportunities for pockets/ focal points of native planting and habitat enhancements

#### **Crusher Fines Trail Surfacing**

As stated by the American Trails, for accessible trails, try to keep the outslope and crown to 2% maximum. In locations where surface pitch could divert a wheelchair into a dangerous place, the cross slope should be as close to 0% as possible. To make the surface harder and smoother, lime or some other stabilizing agents may be added to the crusher fines so that it will be set up harder and remain that way for longer periods of time.

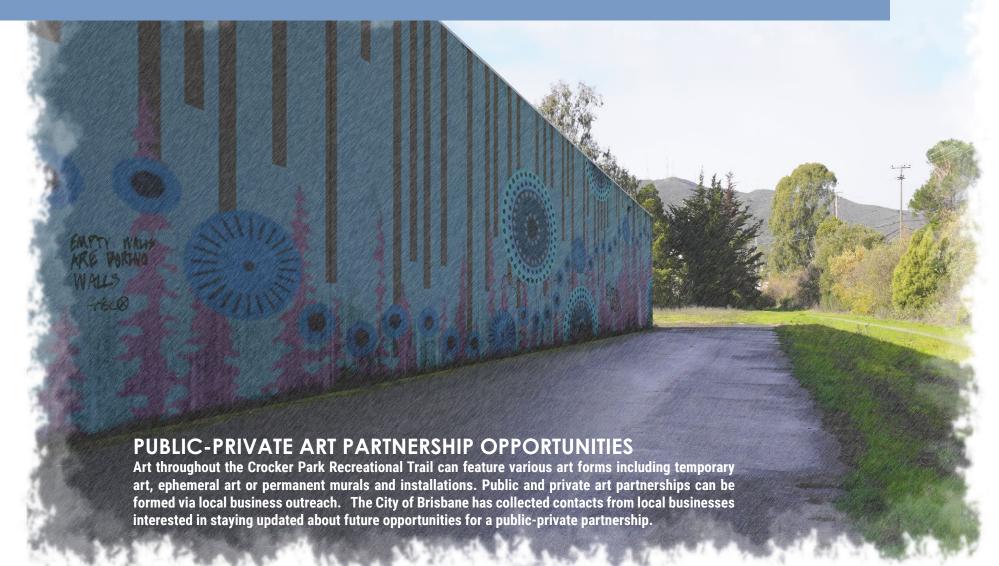
## ART OVERLAY OPPORTUNITIES

**EPHEMERAL ART -** Temporary art that is on display for a limited amount of time. Often created out of natural materials

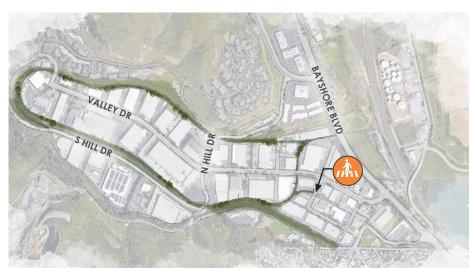
#### PROPOSED SAFETY ENHANCEMENTS AT S HILL DRIVE

Sketches graphically represent the recommended safety enhancements from the traffic assessment memorandum

# Remove existing crossing and relocate to align with trail location as shown above Remove existing crossing and replace with hawk at new location.

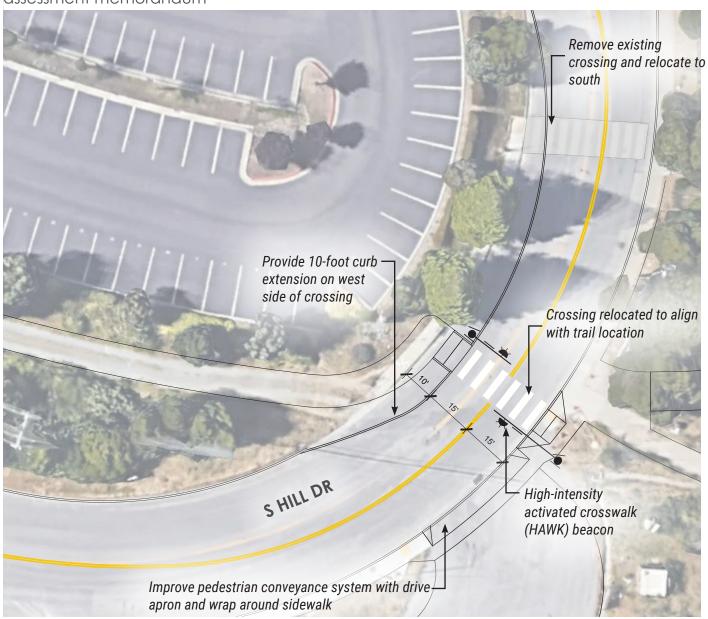
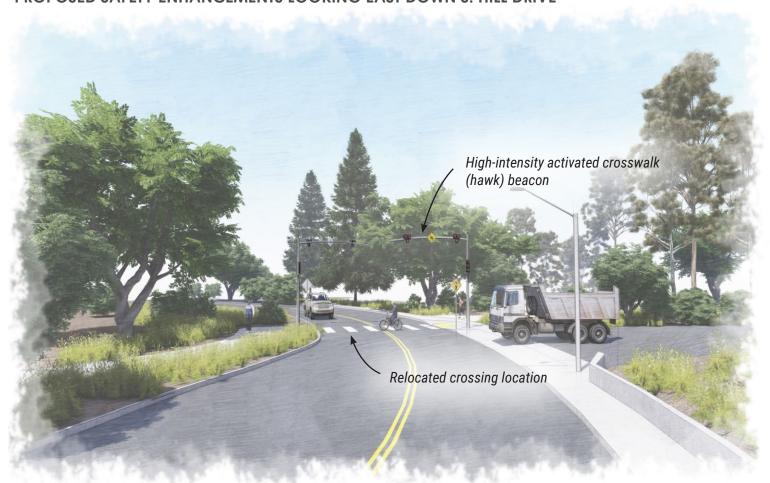
HAWK SIGNAL (High-Intensity Activated crosswalk)

The Crocker Park Recreational Trail crosses South Hill Drive at the apex of a curve. There is an existing marked crosswalk located approximately 80 feet north of the trail location. The crossing includes double sided pedestrian crossing signs with RRFB warning lights and advance pedestrian warning signs with RRFB warning lights in advance of the crossing in each direction. There are no signs which direct trail users to the marked crosswalk.

Assuming that the crosswalk is relocated towards the south at the existing trail location and a 10-foot curb extension is provided on the west side of the crossing, resulting sight distance would be: 190 feet (minimum) from the east side and 140 feet (minimum) from the west side. This condition would also require the installation of measures to reduce vehicle approach speeds. The street cross section could consist of (from west to east ) 10foot curb extension, 15-foot travel lane, 15-foot travel lane with no parking allowed on this section of the street.

It should be noted that neither the existing crossing location nor the relocated crossing scenario provides the minimum stopping sight distance standards. Therefore, the City may wish to consider either a required stop control which can be achieved through the installation of a Hawk signal, or provide a raised crossing which would physically reduce speeds in the corridor to less than 25 mph.

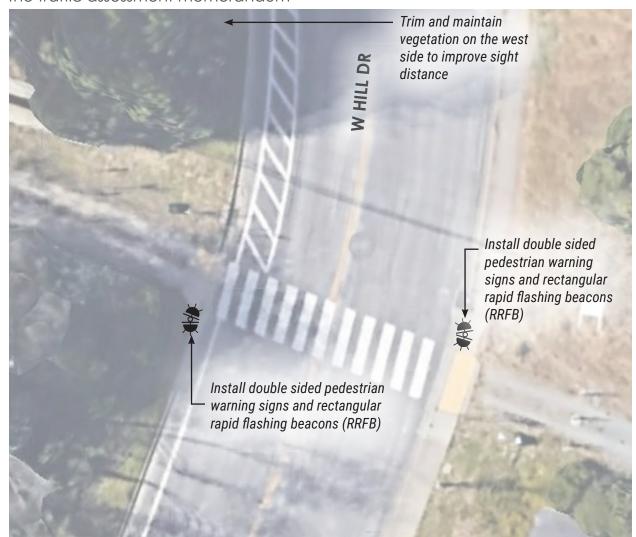
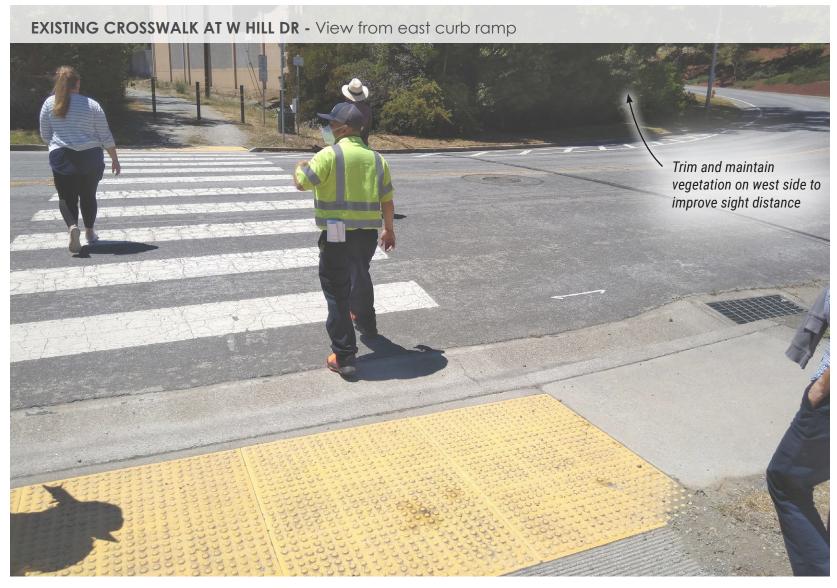
#### PROPOSED SAFETY ENHANCEMENTS AT W HILL DRIVE

Sketches graphically represent the recommended safety enhancements from the traffic assessment memorandum

An existing midblock crossing is provided with pedestrian warning signs on each side of the crossing. Existing speed limits are 30 mph north of the crossing and 40 mph south of the crossing. Shoulder buffered striping is provided on the west side.

- Install double sided pedestrian warning signs on both sides of the crossing.
- As much as possible, remove vegetation on west side to increase sight distance to the north.
- Due to the restricted sight distance to the north due to the vegetation and curve, install Rectangular Rapid Flashing Beacons ((RRFB) on both sides to be activated by pedestrian push buttons.

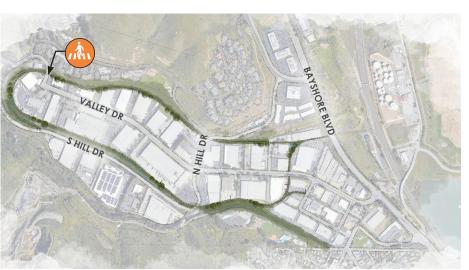
#### PROPOSED SAFETY ENHANCEMENTS AT N HILL DRIVE - OPTION A

Sketches graphically represent the recommended safety enhancements from the traffic

During the trail master planning process, the Public Works department and the project Traffic Engineer worked together to evaluate the trail crossing at N. Hill Drive. Based on their discussions, the following two crossing solutions are viable pending additional analysis. Both recommendations are focused on improving sight distances from the southern side of the crossing.

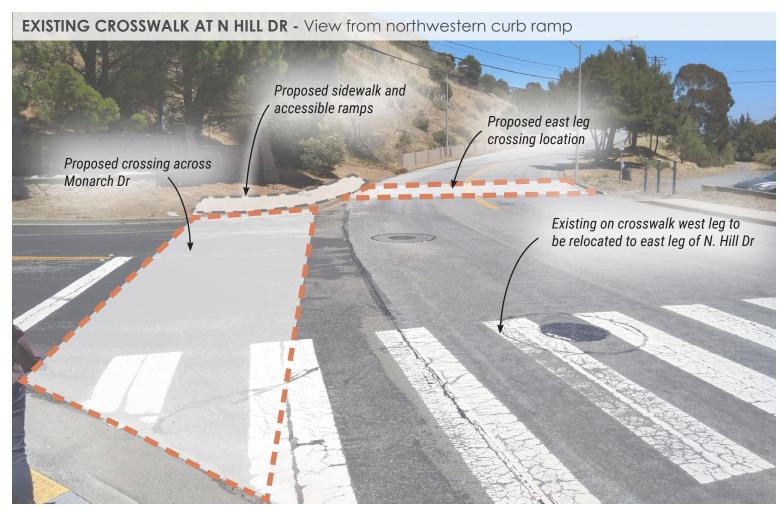
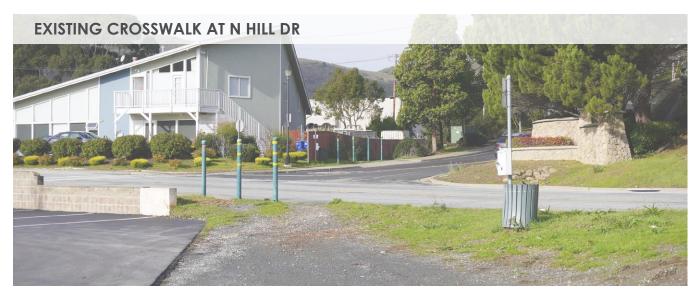
assessment memorandum Install double sided pedestrian warning Planned class II bike as signs shown in the 2017 BPMP Install double sided Proposed pedestrian warning crosswalks Existing west leg Install double sided crosswalk to be pedestrian warning relocated to east signs leg of N. Hill Dr to eliminate left turn vehicle stacking in crosswalk Provide 6-foot curb extension on east side of N. Hill Dr to increase sight distance Planned class II bike lane ends at Monarch Dr as shown in the 2017 BPMP

The Crocker Park Recreational Trail crosses North Hill Drive on the south leg of the intersection with Monarch Drive. There is an existing marked crosswalk with no pedestrian warning signs. The existing speed limit is 35 mph.

Sight distance between vehicles and the pedestrian waiting position from the east side, which is limited by the curve on North Hill Drive, is approximately 180 feet to the south and 200 feet to the north. Based on current sight distant standards, 250 feet of sight distance is needed for speeds of 35 mph. Sight distance conditions from the west side meets these standards. Because of the restricted sight distance from the east side, either an RRFB or Hawk installation would be needed for enhanced pedestrian crossing safety. As an alternative, a raised crosswalk could be provided to reduce speeds.

Assuming that the crosswalk is relocated to the north leg of the intersection, the resulting site distance would be approximately 200 feet from the east side towards and north and the south. By adding a 6-foot curb extension on the eastside, the sight distance could be increased to 250 feet which would be adequate for the 35 mile per hour speeds. Again, sight distance conditions from the west side meet the required standards. This approach would not need additional measures to increase warning or reduce speeds.

- If the existing crosswalk is maintained, install RRFBs, HAWK, a raised crossing, or remove trees and vegetation to obtain adequate sight distance.
- If the crosswalk is relocated to the north leg of the intersection, provide a 6-foot curb extension on the east side to increase sight distance.
- Install double sided pedestrian warning signs under either scenario.

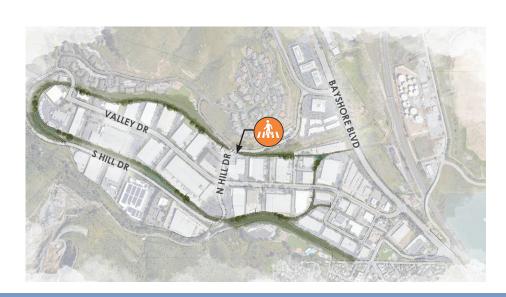
#### PROPOSED SAFETY ENHANCEMENTS AT CYPRESS LANE

Sketches graphically represent the recommended safety enhancements from the traffic assessment memorandum

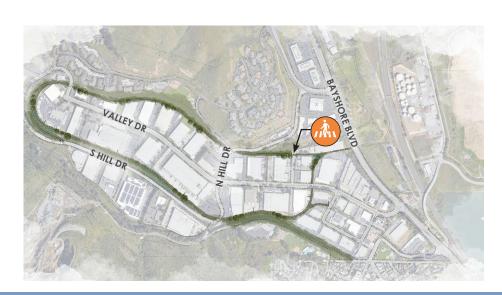
#### PROPOSED SAFETY ENHANCEMENTS AT VALLEY DRIVE

Sketches graphically represent the recommended safety enhancements from the traffic assessment memorandum

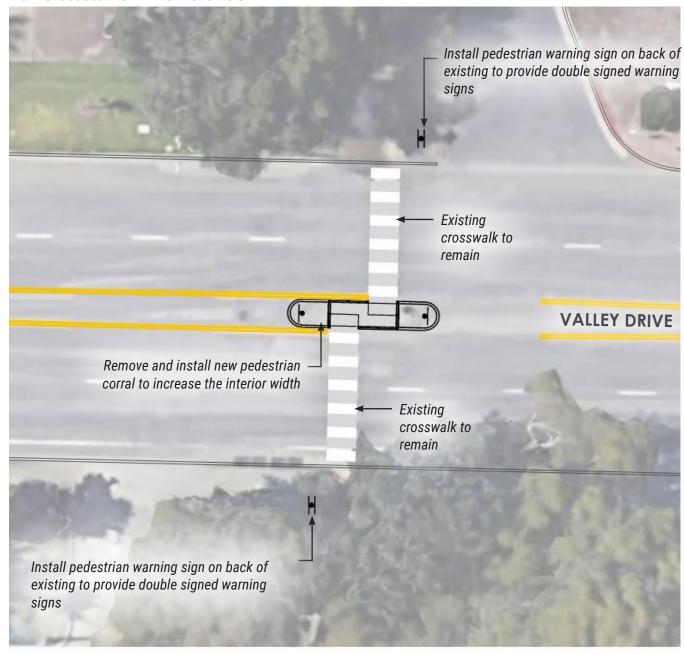
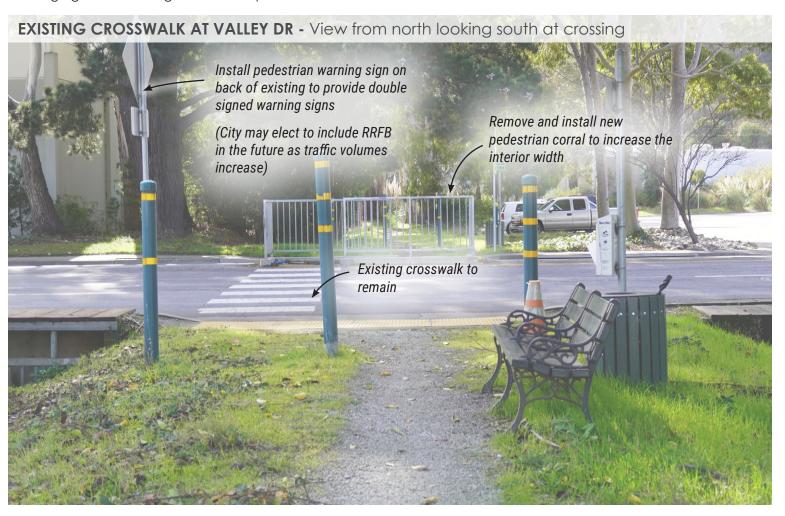
The Public Works Department and the project Traffic Engineer have evaluated the historical trail usage and average daily traffic counts to determine the warranted safety enhancements for the crossing. The City may elect to install the additional safety measure of a Rectangular Rapid Flashing Beacon (RRFB) device on the double sided pedestrian warning signs as trail usage and traffic patterns increase.

An existing midblock crossing is provided with pedestrian warning signs on each side of the crossing.

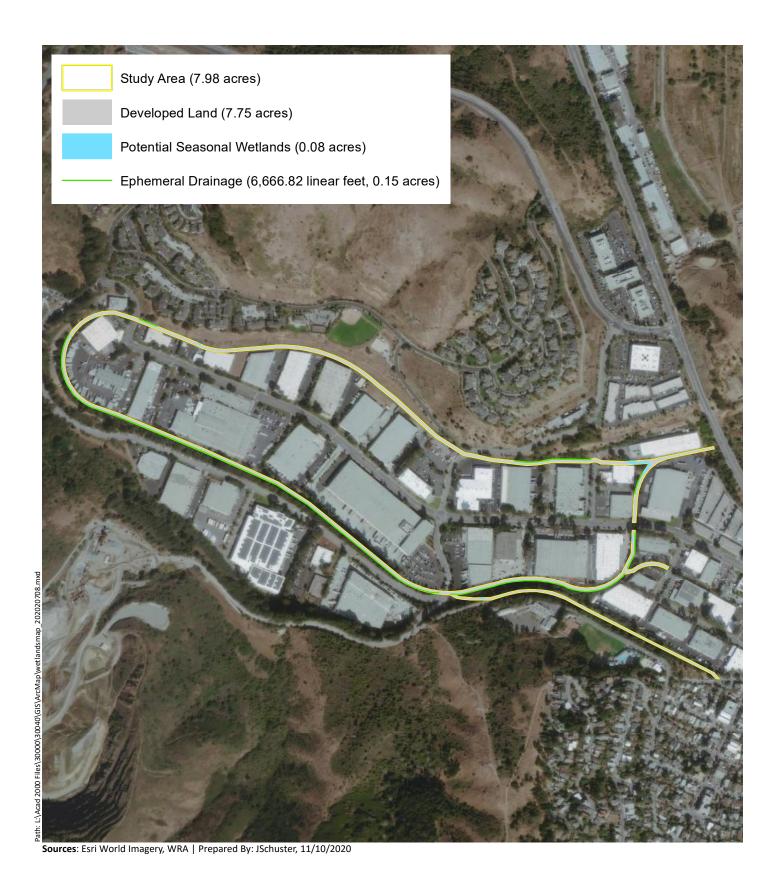
Figure 2. Wetlands in the Study Area

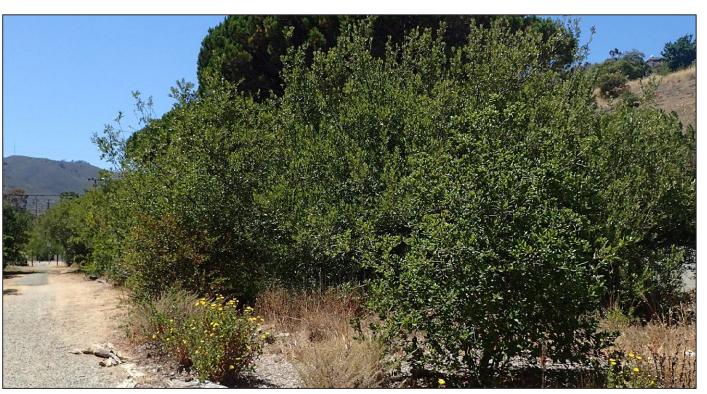
Photograph 1: Representative photograph of riparian vegetation along an ephemeral ditch and potential wetland within the Study Area.

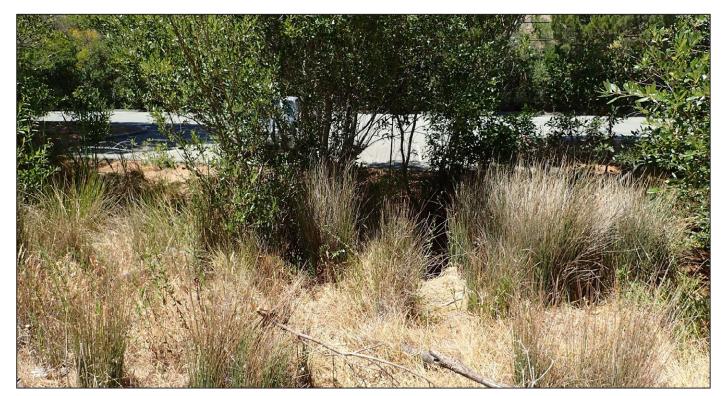
Photograph 2: Representative photograph of hydrophytic vegetation (*Juncus effusus*, *Salix* sp., *Cyperus eragrostis*) in one of the potential wetlands within the Study Area.

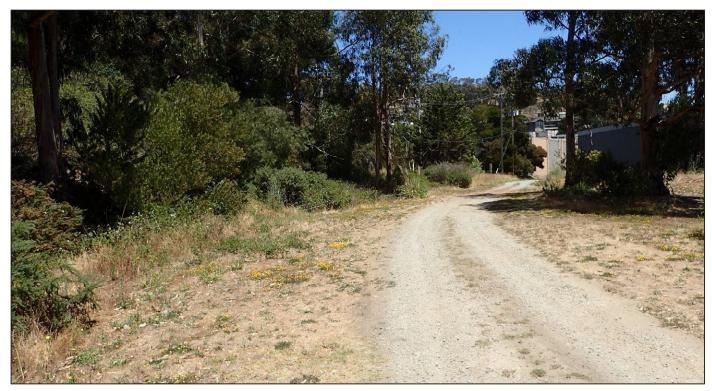
Photograph 3: Representative photograph of ruderal habitat that dominates most of the trail within the Study Area.

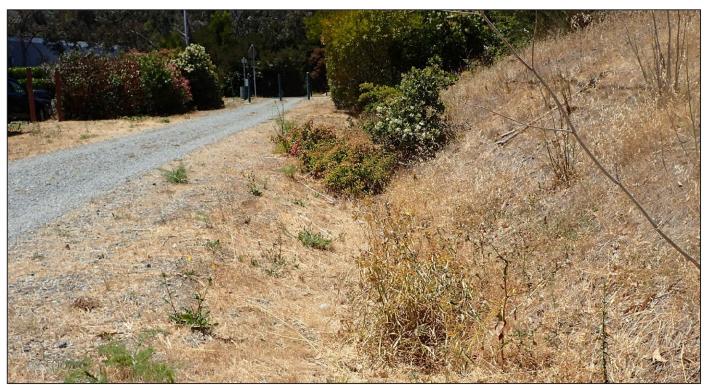
Photograph 4: Representative photograph of an ephemeral ditch supporting some hydrophytic vegetation (e.g. *Cyperus eragrostis* and *Polypogon monspeliensis*) within the Study Area.

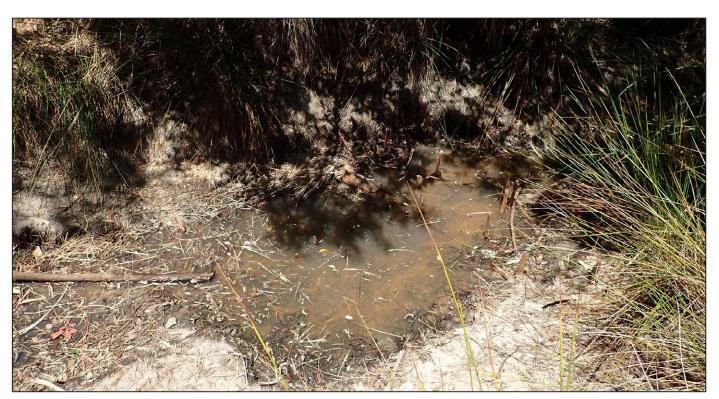
Photograph 5: Representative photograph of a potential wetland with standing water and supporting some hydrophytic vegetation (e.g. *Juncus effusus* and *Salix* sp.) within the Study Area

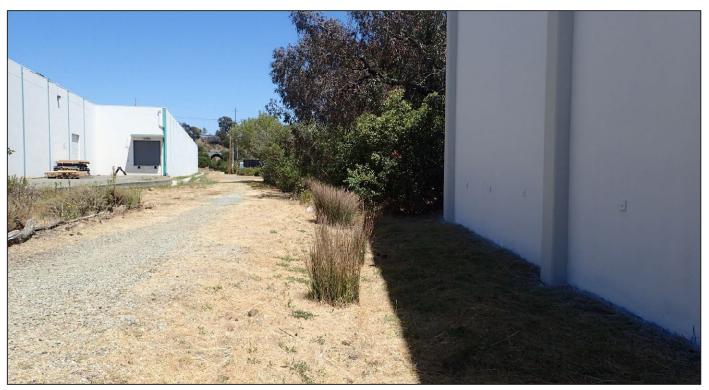
Photograph 6: Representative photograph of a potential wetland within the Study Area.
